# CONSERVATION OF TEPE MARANJAN & TOPDARA, AFGHANISTAN 2016-20

AFGHAN CULTURAL HERITAGE  
CONSULTING ORGANIZATION

**CONSERVATION OF  
TEPE MARANJAN & TOPDARA  
AFGHANISTAN 2016-20**

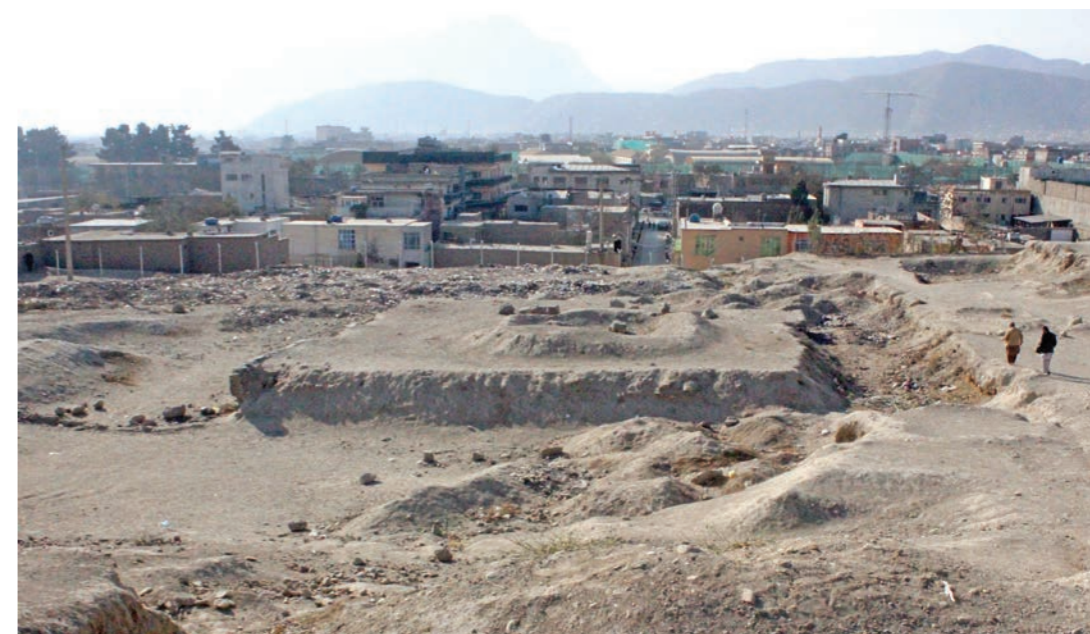
*Stupa platform at Tepe Maranjan from the north 2016*

While the square form of the stupa platform could be clearly made out from the slope to the north, it was not clear at this initial stage if any of the original masonry survived under the ground along the north and west sides. On the south side, a wide stair leading up to the platform could be discerned.

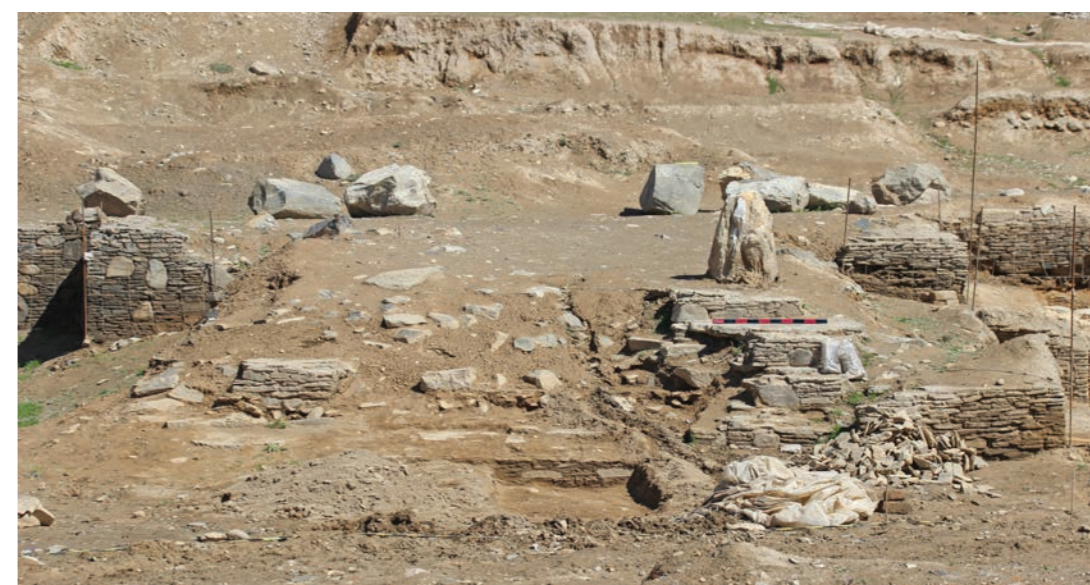
*Stair on the south side of the stupa platform at Tepe Maranjan 2017*

The final stage of work on the platform entailed reconstruction of stairs on the south side. Traces of the original risers and treads enabled reconstruction of 10 steps leading up to the platform, flanked by walls around which the string course at the base of the platform extends.

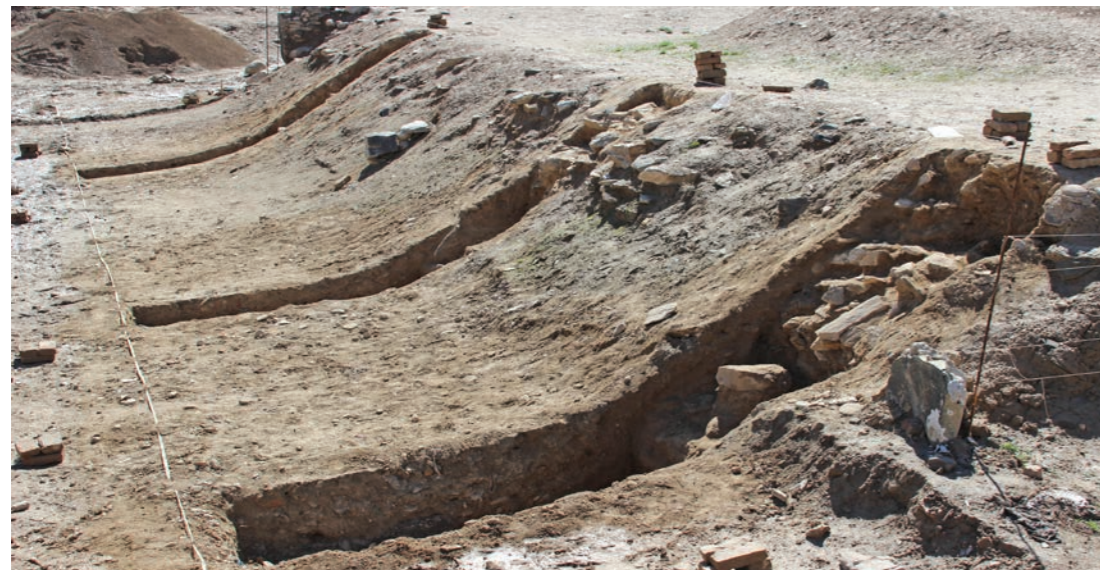
Following detailed documentation of the exposed structure, several shallow trenches were excavated perpendicular to the platform to establish what might lie below ground. What emerged was stone masonry (between 90cm and 1 metre wide) along the north and west sides, forming a lower plinth that abuts the platform and increases the dimensions to 24.3 metres square.

*Excavation of trial trenches along the north side of the stupa platform 2016*

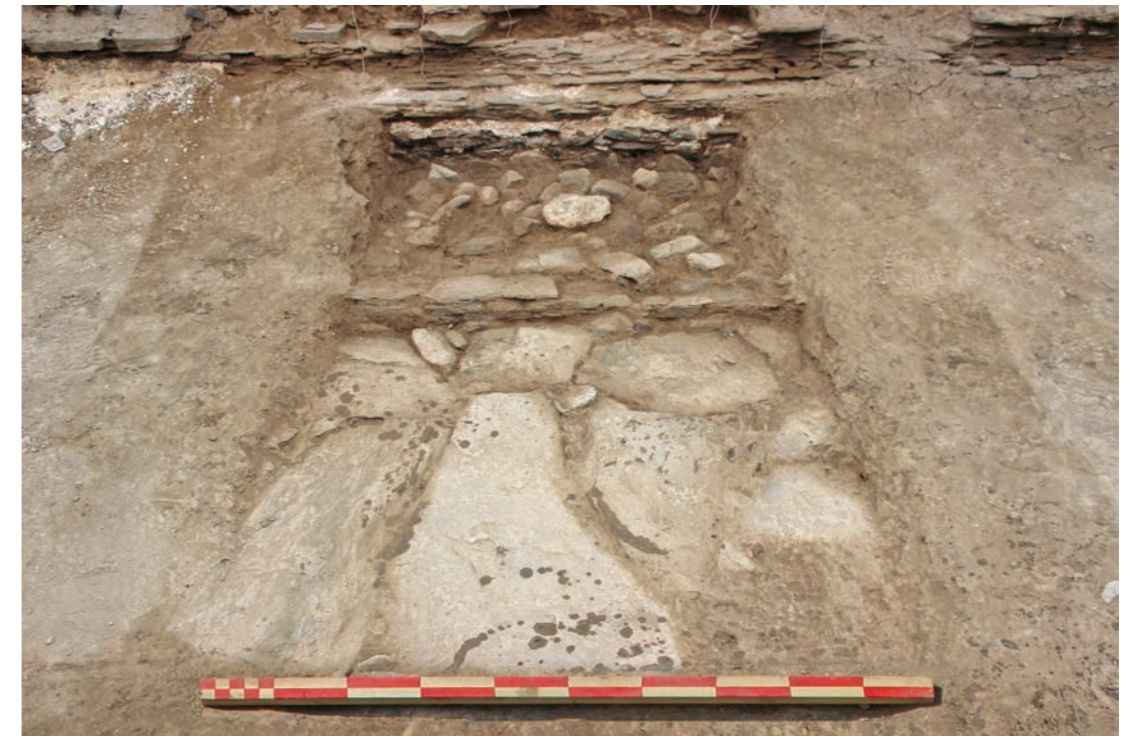
*Detail of excavated platform (top), plinth (center) and stone paving (bottom)*

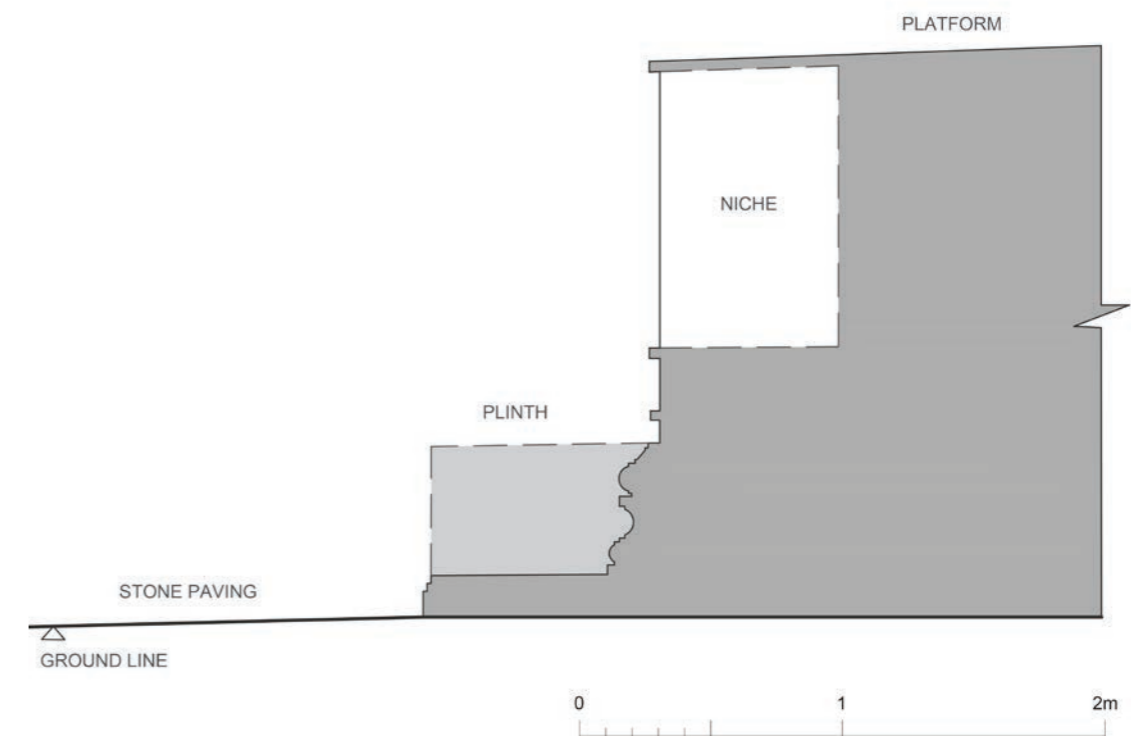
*Schematic section through the plinth and platform at Tepe Maranjan*

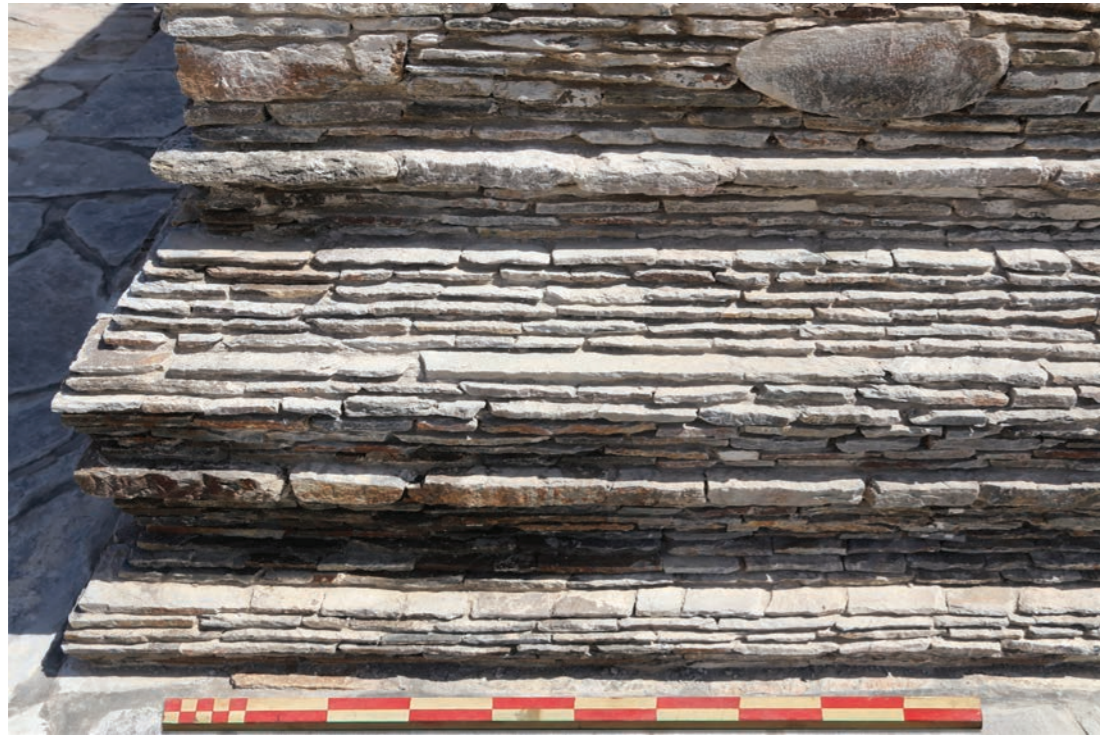
*Detail of restored string-course at base of stupa platform at Tepe Maranjan*

Below the diaper masonry on the upper walls of the platform is a string-course (largely concealed behind the outer plinth on the north and west sides) formed from fragile pieces of schist that had all but disintegrated in places.

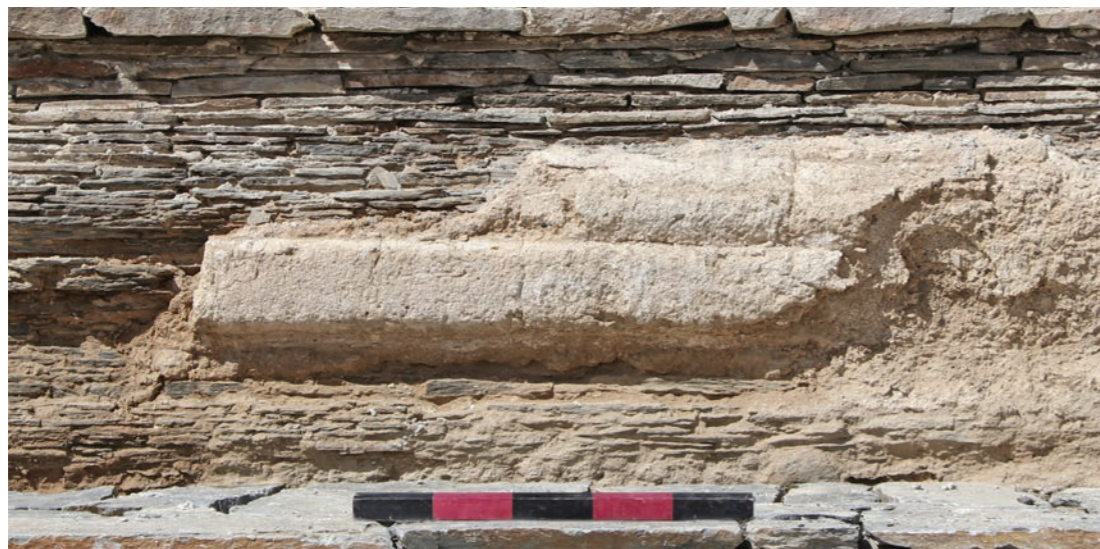
*Detail of original lime plaster on west side of platform at Tepe Maranjan 2017*

On the east and west sides, areas of the original lime plaster and pigment suggest that the platform was built as a finished structure, with the outer plinth added subsequently. Laboratory analysis in 2018 of two fragments of the plaster indicated that it comprised lime, straw and mineral aggregate, with what might be a gold alloy, perhaps from the original decorative covering.

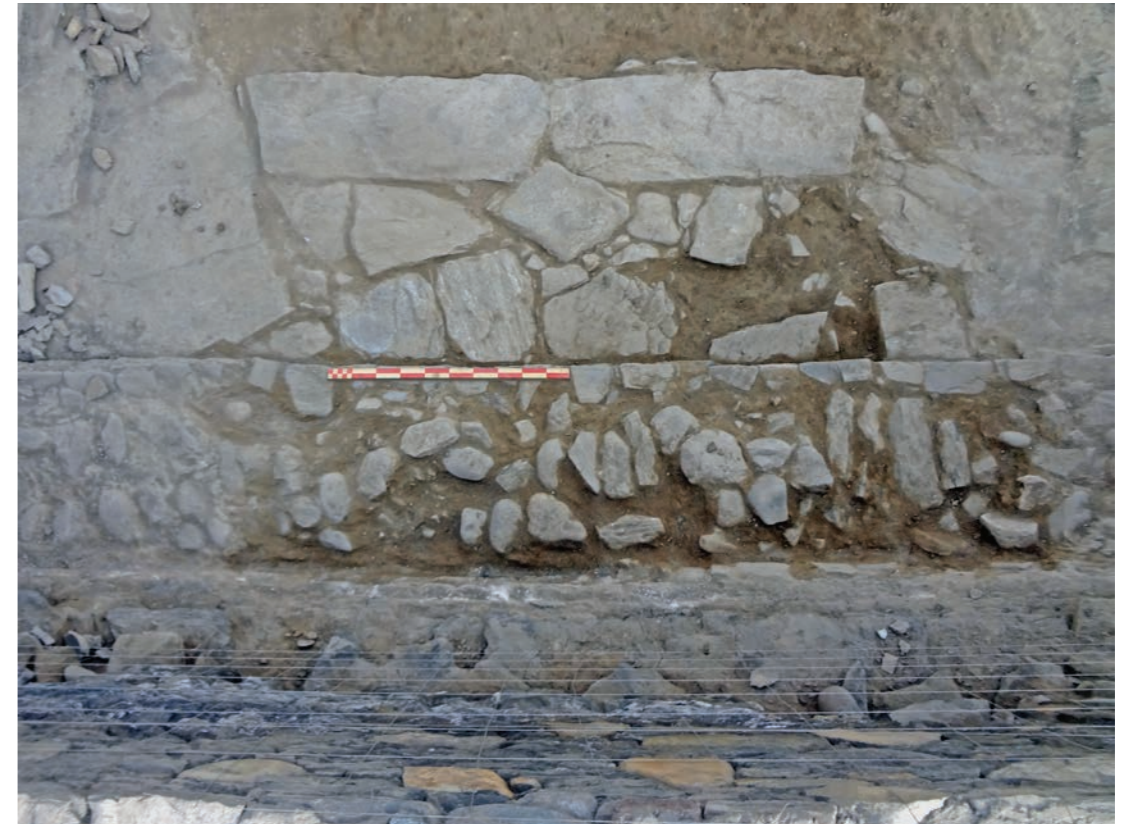
*View from above of excavation on east side showing platform (bottom), remains of plinth (center) and stone paving (top) 2017*

All that survives of the outer plinth along the east and south sides (exposed at the start of conservation) are a few courses of stone masonry. On the north and west sides, excavation revealed sections of masonry of up to 70 cm high, with engaged piers and traces of a modest entablature on the outside face.

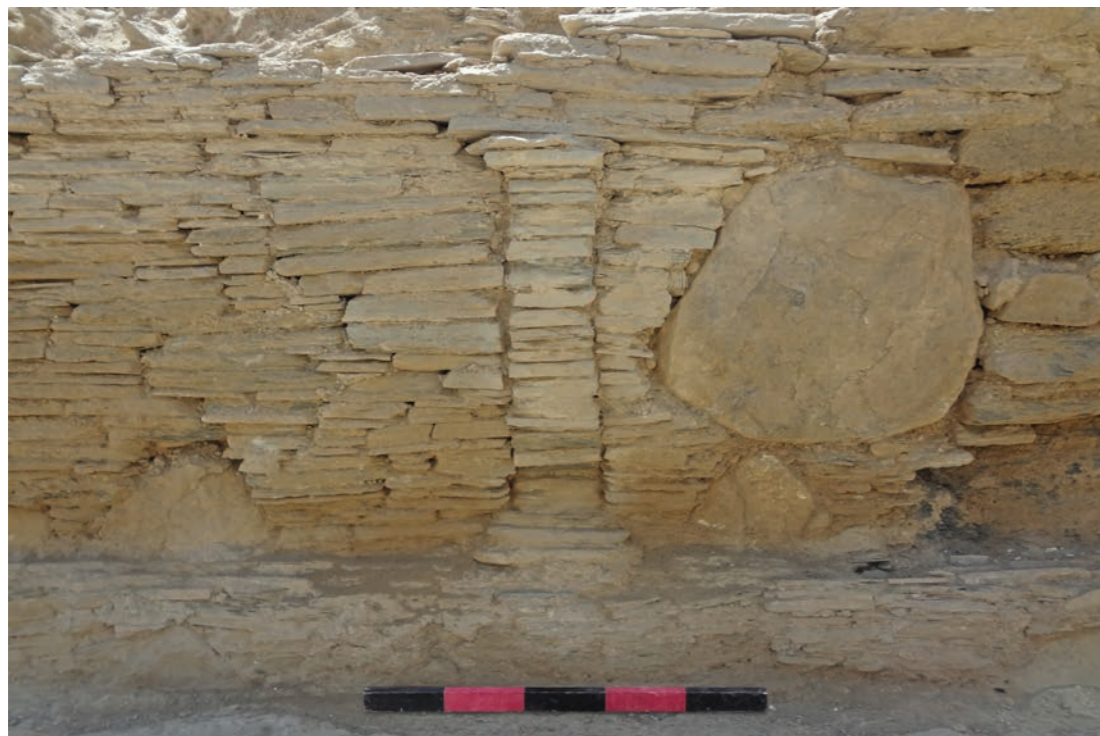
*Detail of north elevation of the excavated plinth, prior to stabilization 2017*

The function of the outer plinth is unclear. The masons who constructed it did not key the new masonry into the platform and its modest height (no more than 75cm above ground) means that it could not have served as a structural buttress to the inner structure. It seems more likely to have been added to provide an outer ambulatory for the faithful to circle the stupa; given that such rituals must have been well-established, it is unclear why it was not part of the original construction of the platform. Several other stupas in the region (Topdara and Guldara) have lower plinths surrounding a central platform, but these are integral, suggesting they were constructed at the same time.

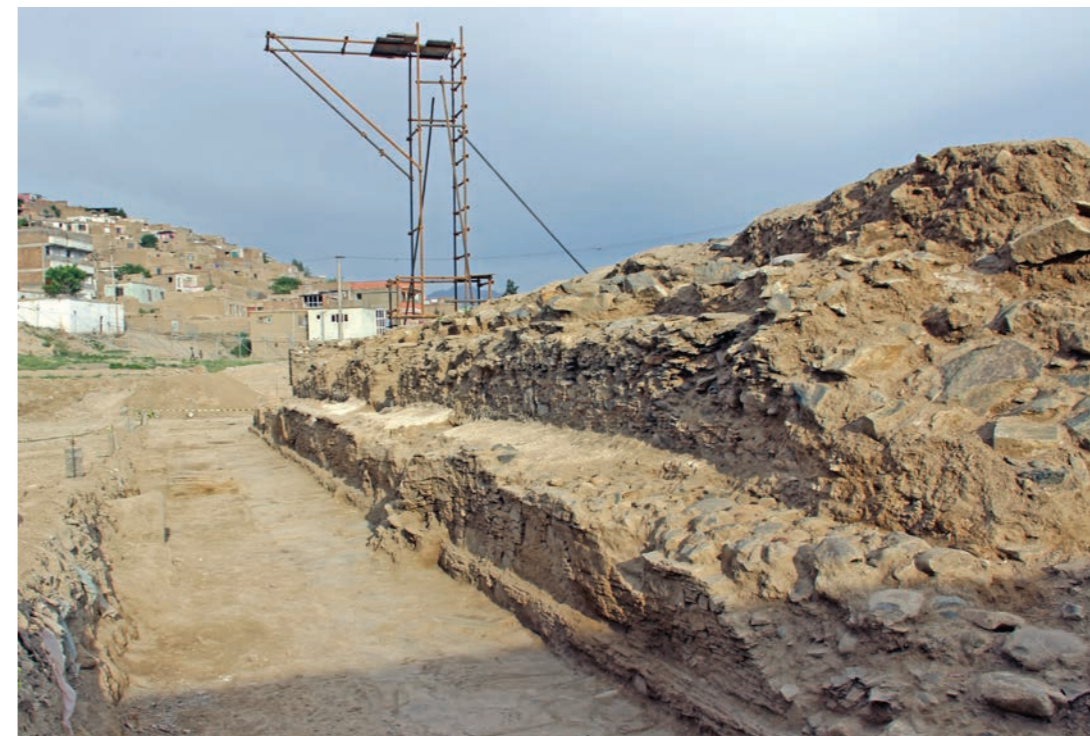
*Plinth (center) along the north side in front of platform masonry. The tower in the background was constructed for photographic surveys 2017*

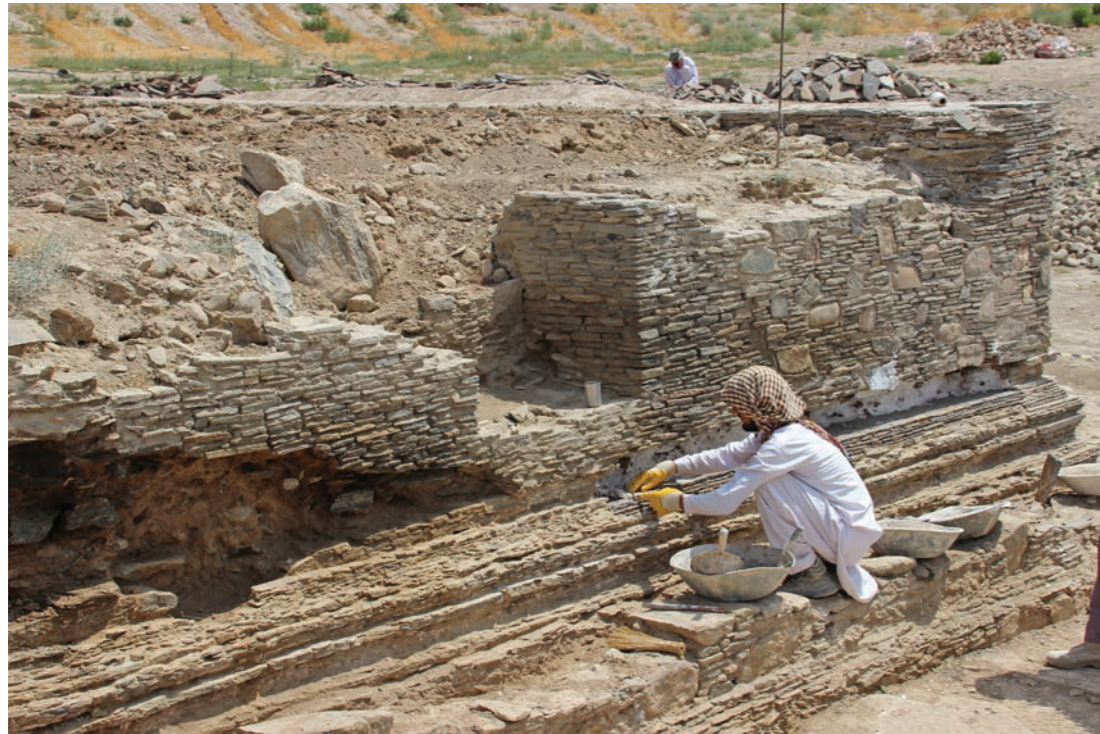
Above the level of the outer plinth are niches (95cm wide) in the center of the north, east and west elevations of the platform, with the stair to the south flanked by a pair of niches of similar dimensions. The niches in all likelihood housed plaster or stone figures.

*Conservation of south side of platform, at Tepe Naranjan showing niche 2017*

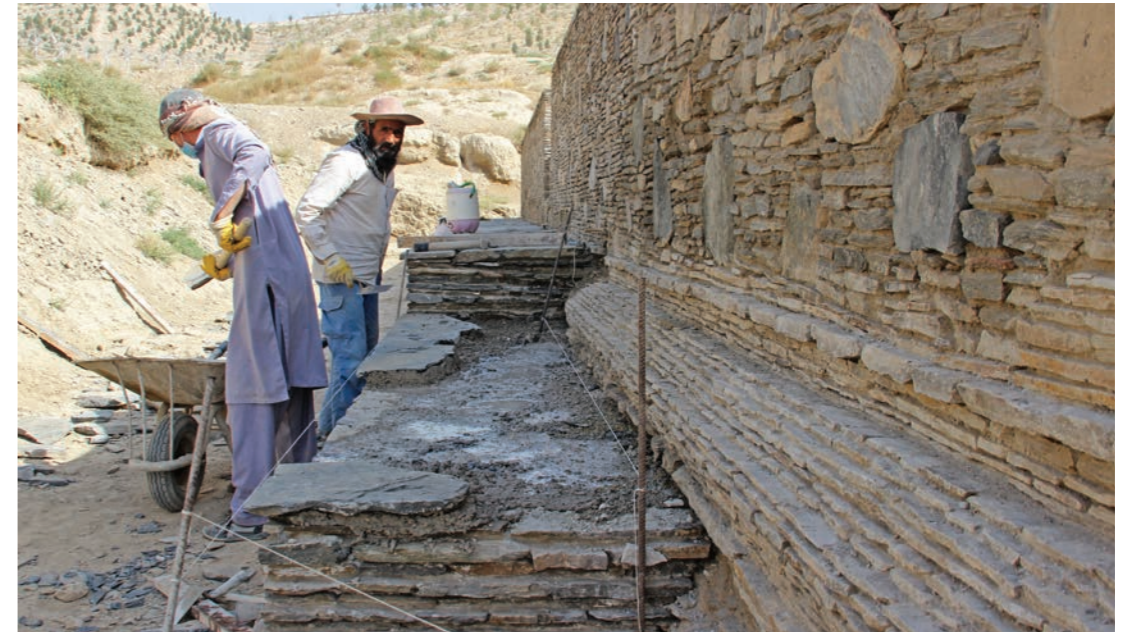
*Stabilization of the plinth (center) outside of the platform (right) 2017*

After documentation as the excavations proceeded, the surviving sections of the outer plinth were stabilized along with the masonry of the platform, re-using where possible schist pieces retrieved from the rubble, laid in lime mortar. Sections of new infill were laid protruding 1cm from the wall surface, to enable this to be distinguished from the original masonry.

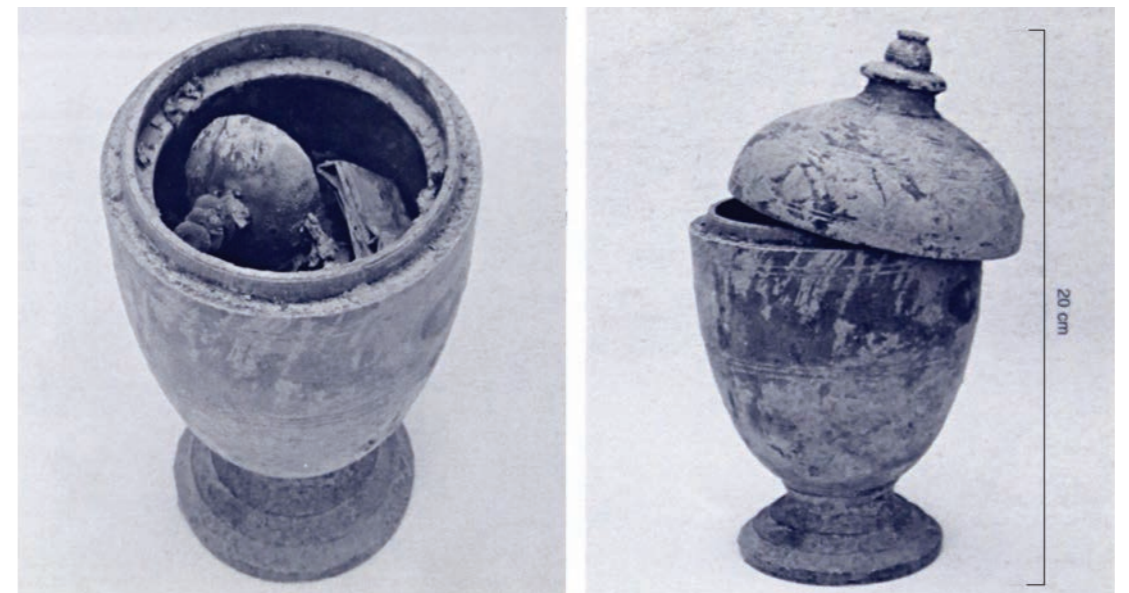
In parallel with these works, an area in the centre of the platform was excavated, in order to establish what might remain of a reliquary found in 1987. No trace of the original reliquary chamber was found, and the surface of the platform was subsequently paved with flat stones laid to falls, to protect the structure and facilitate access by visitors.

*Stone reliquary excavated from the center of the stupa platform 1987*

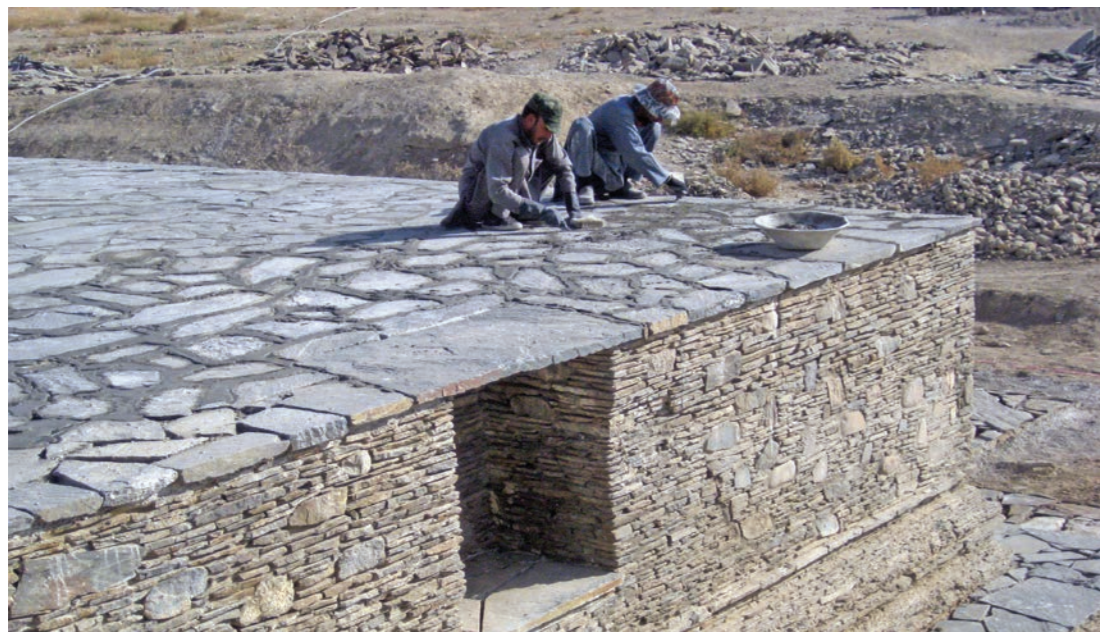
*Laying stone paving on the platform surface 2018*

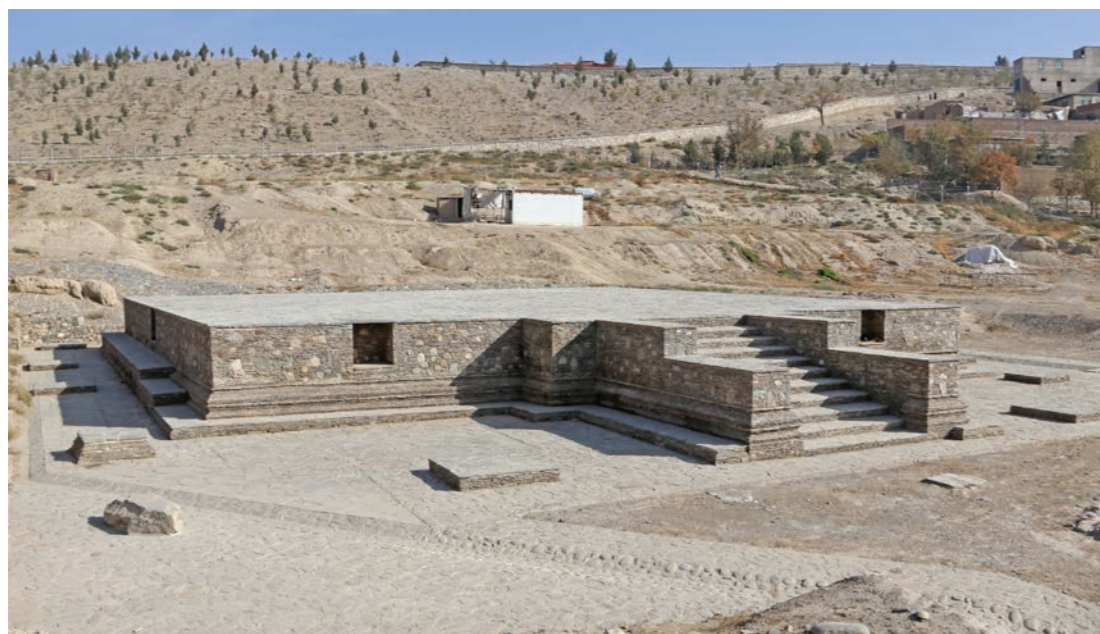
*Stupa platform at Tepe Maranjan after conservation, from the south 2018*

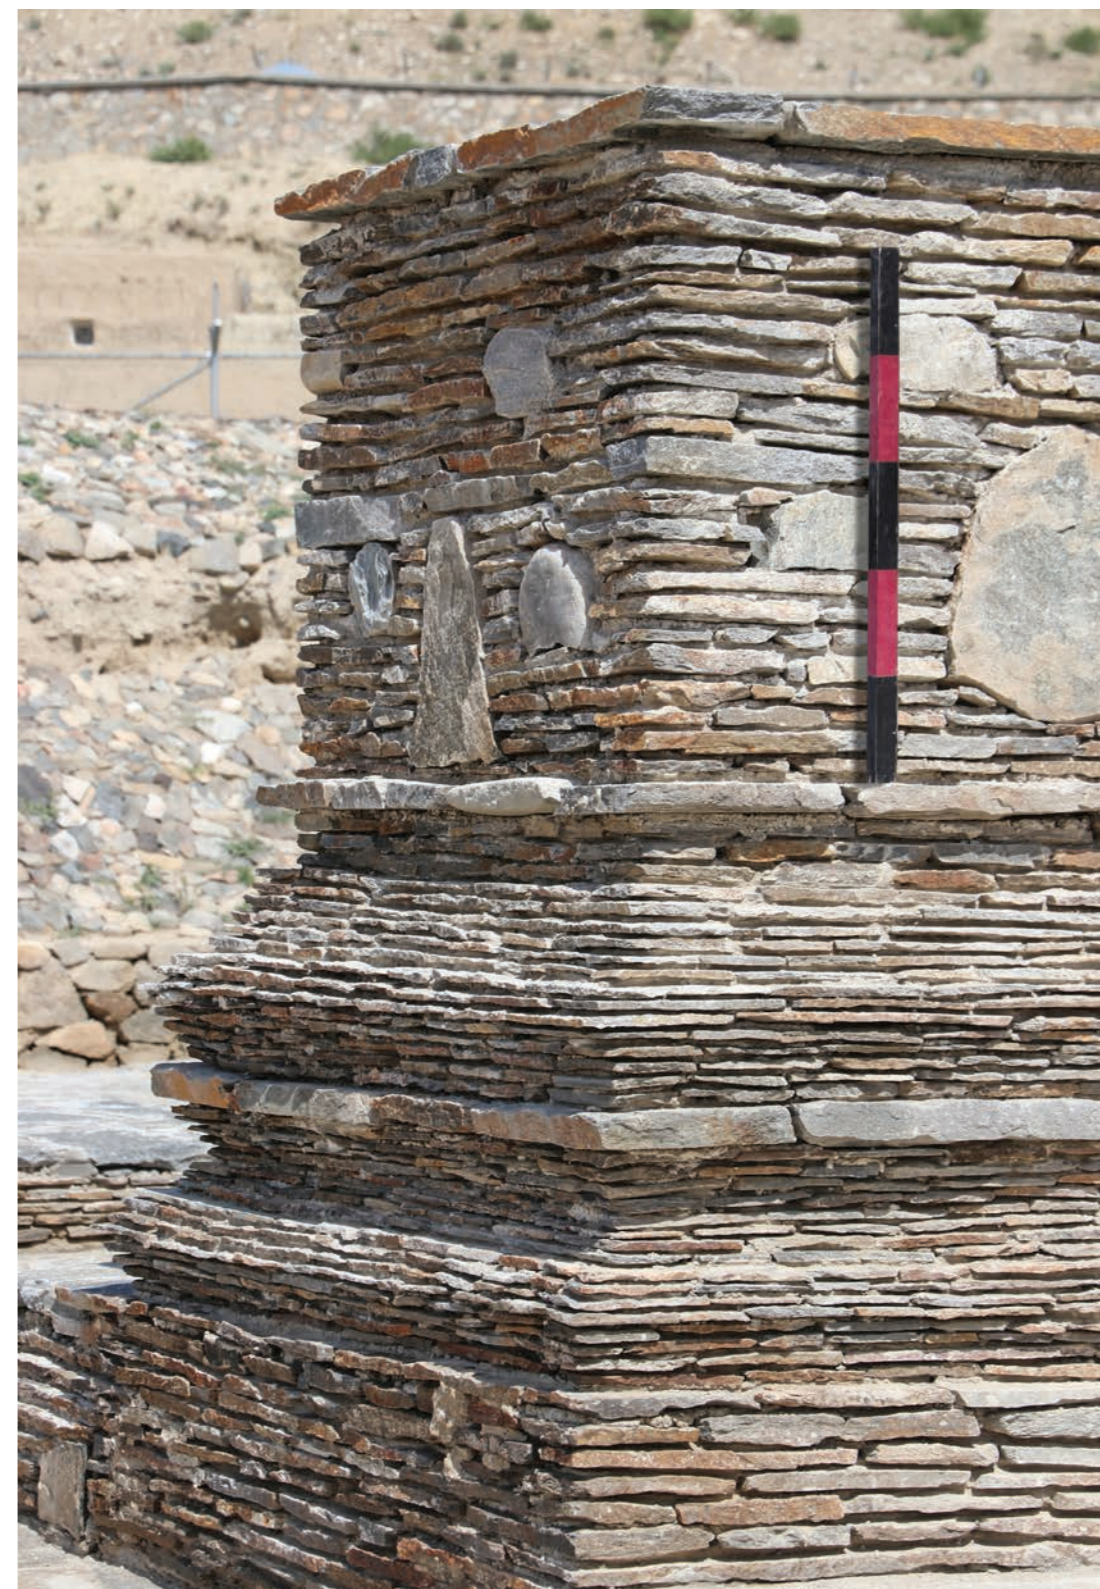
*Detail of restored stone masonry on flanking wall of the south stair 2018*

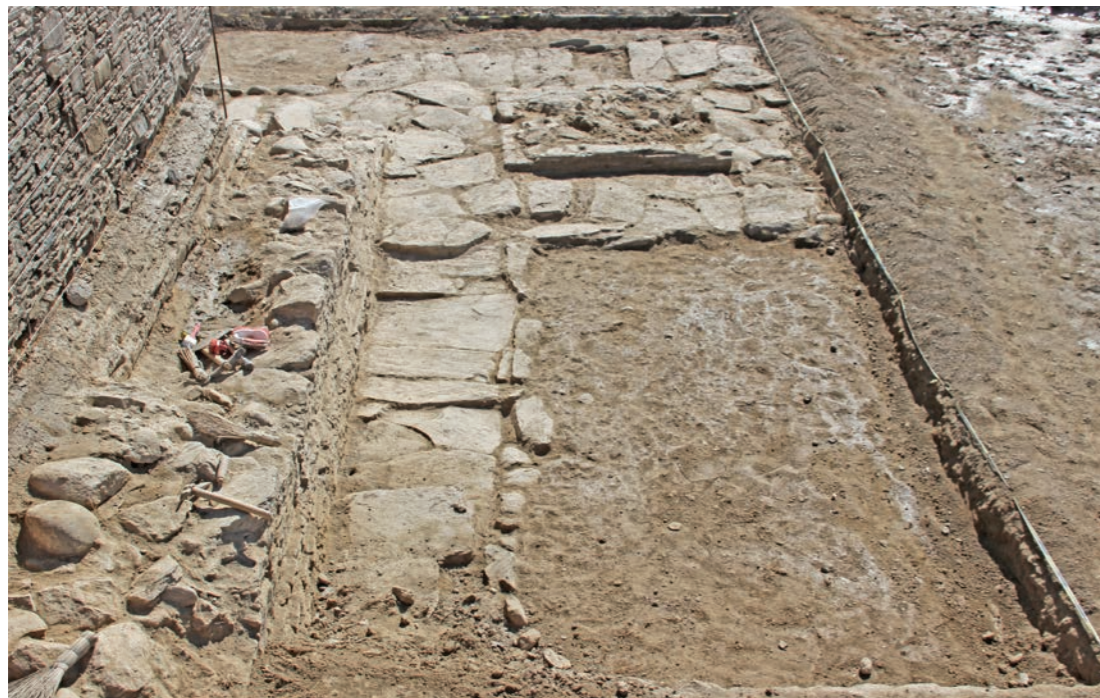
*Area of stone paving at SW corner of the platform, with plinth of secondary stupa to the top-right 2017*

New areas of paving were laid between the original stones, draining to shallow channels aimed at directing surface water away from the stupa platform. As part of measures to protect the platform from surface water draining from higher ground to the north and west, a series of embankments and retaining walls were introduced along with planting of the upper slopes with indigenous trees.

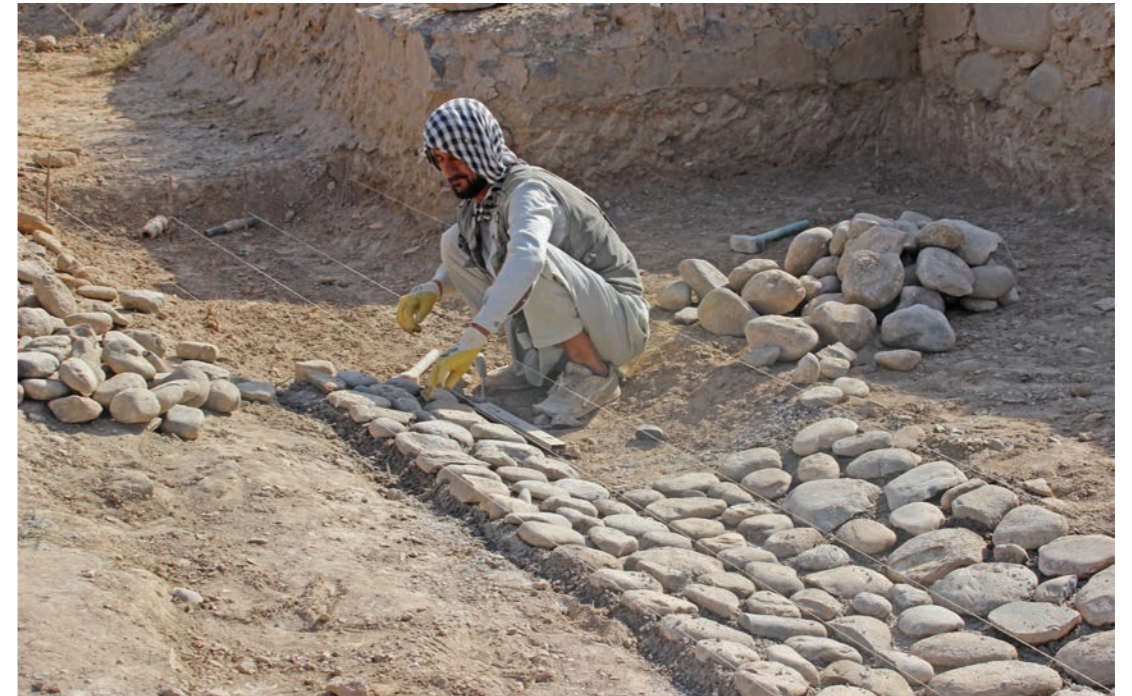
*Construction of surface drain to the west of the platform 2018*

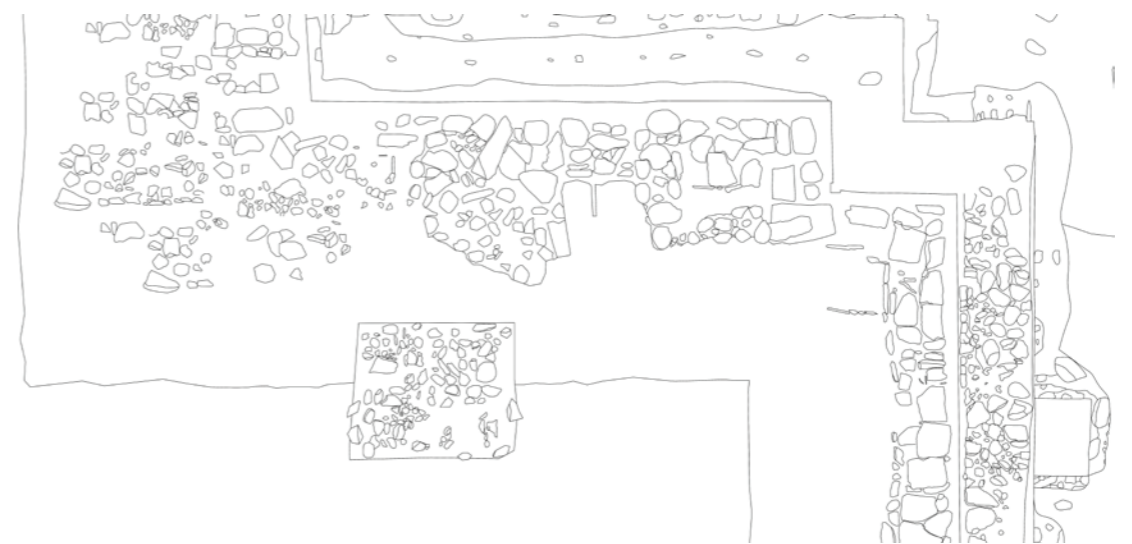
*Detailed documentation of a section of original stone paving*

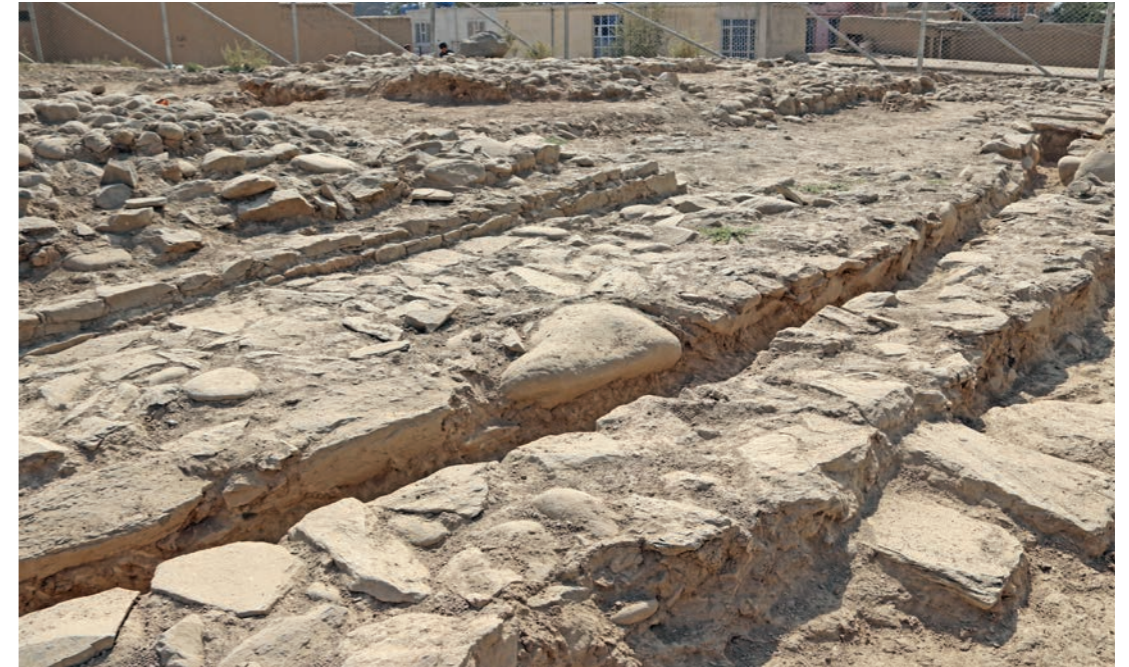
*Stone-lined channel and other structures south of the main platform, after excavation 2018*
