# CONSERVATION OF TEPE MARANJAN & TOPDARA, AFGHANISTAN 2016-20

AFGHAN CULTURAL HERITAGE  
CONSULTING ORGANIZATION

**CONSERVATION OF  
TEPE MARANJAN & TOPDARA  
AFGHANISTAN 2016-20**

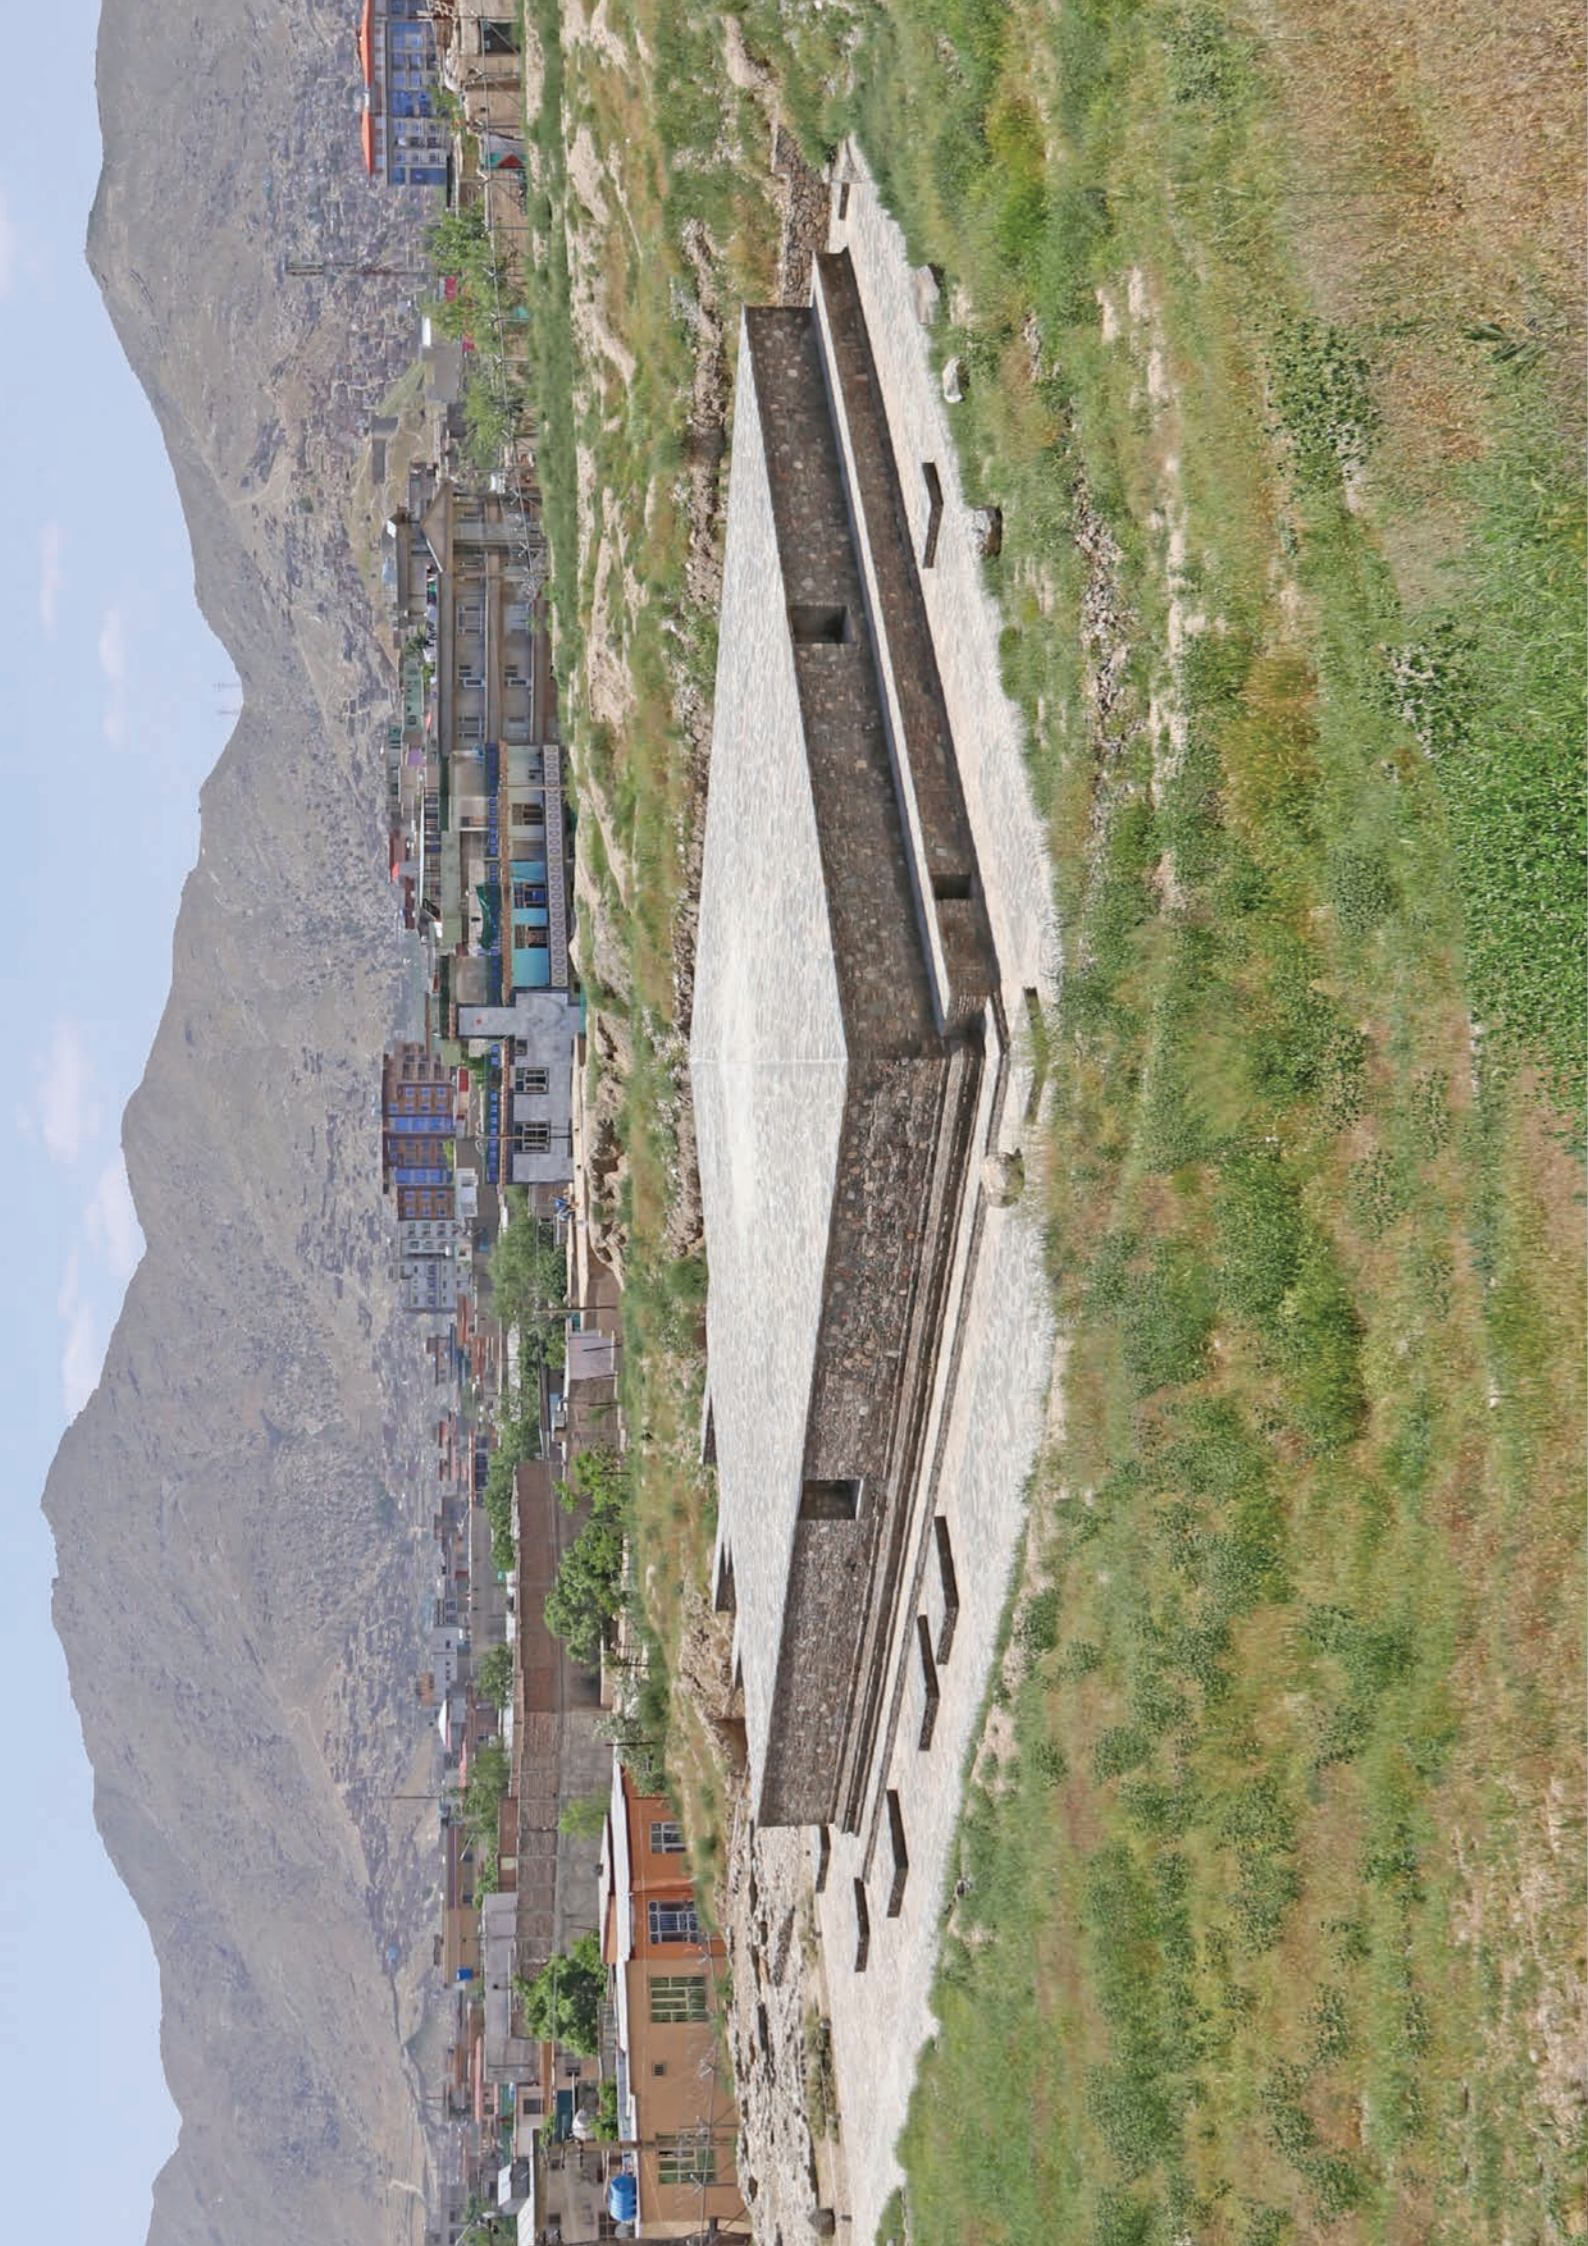
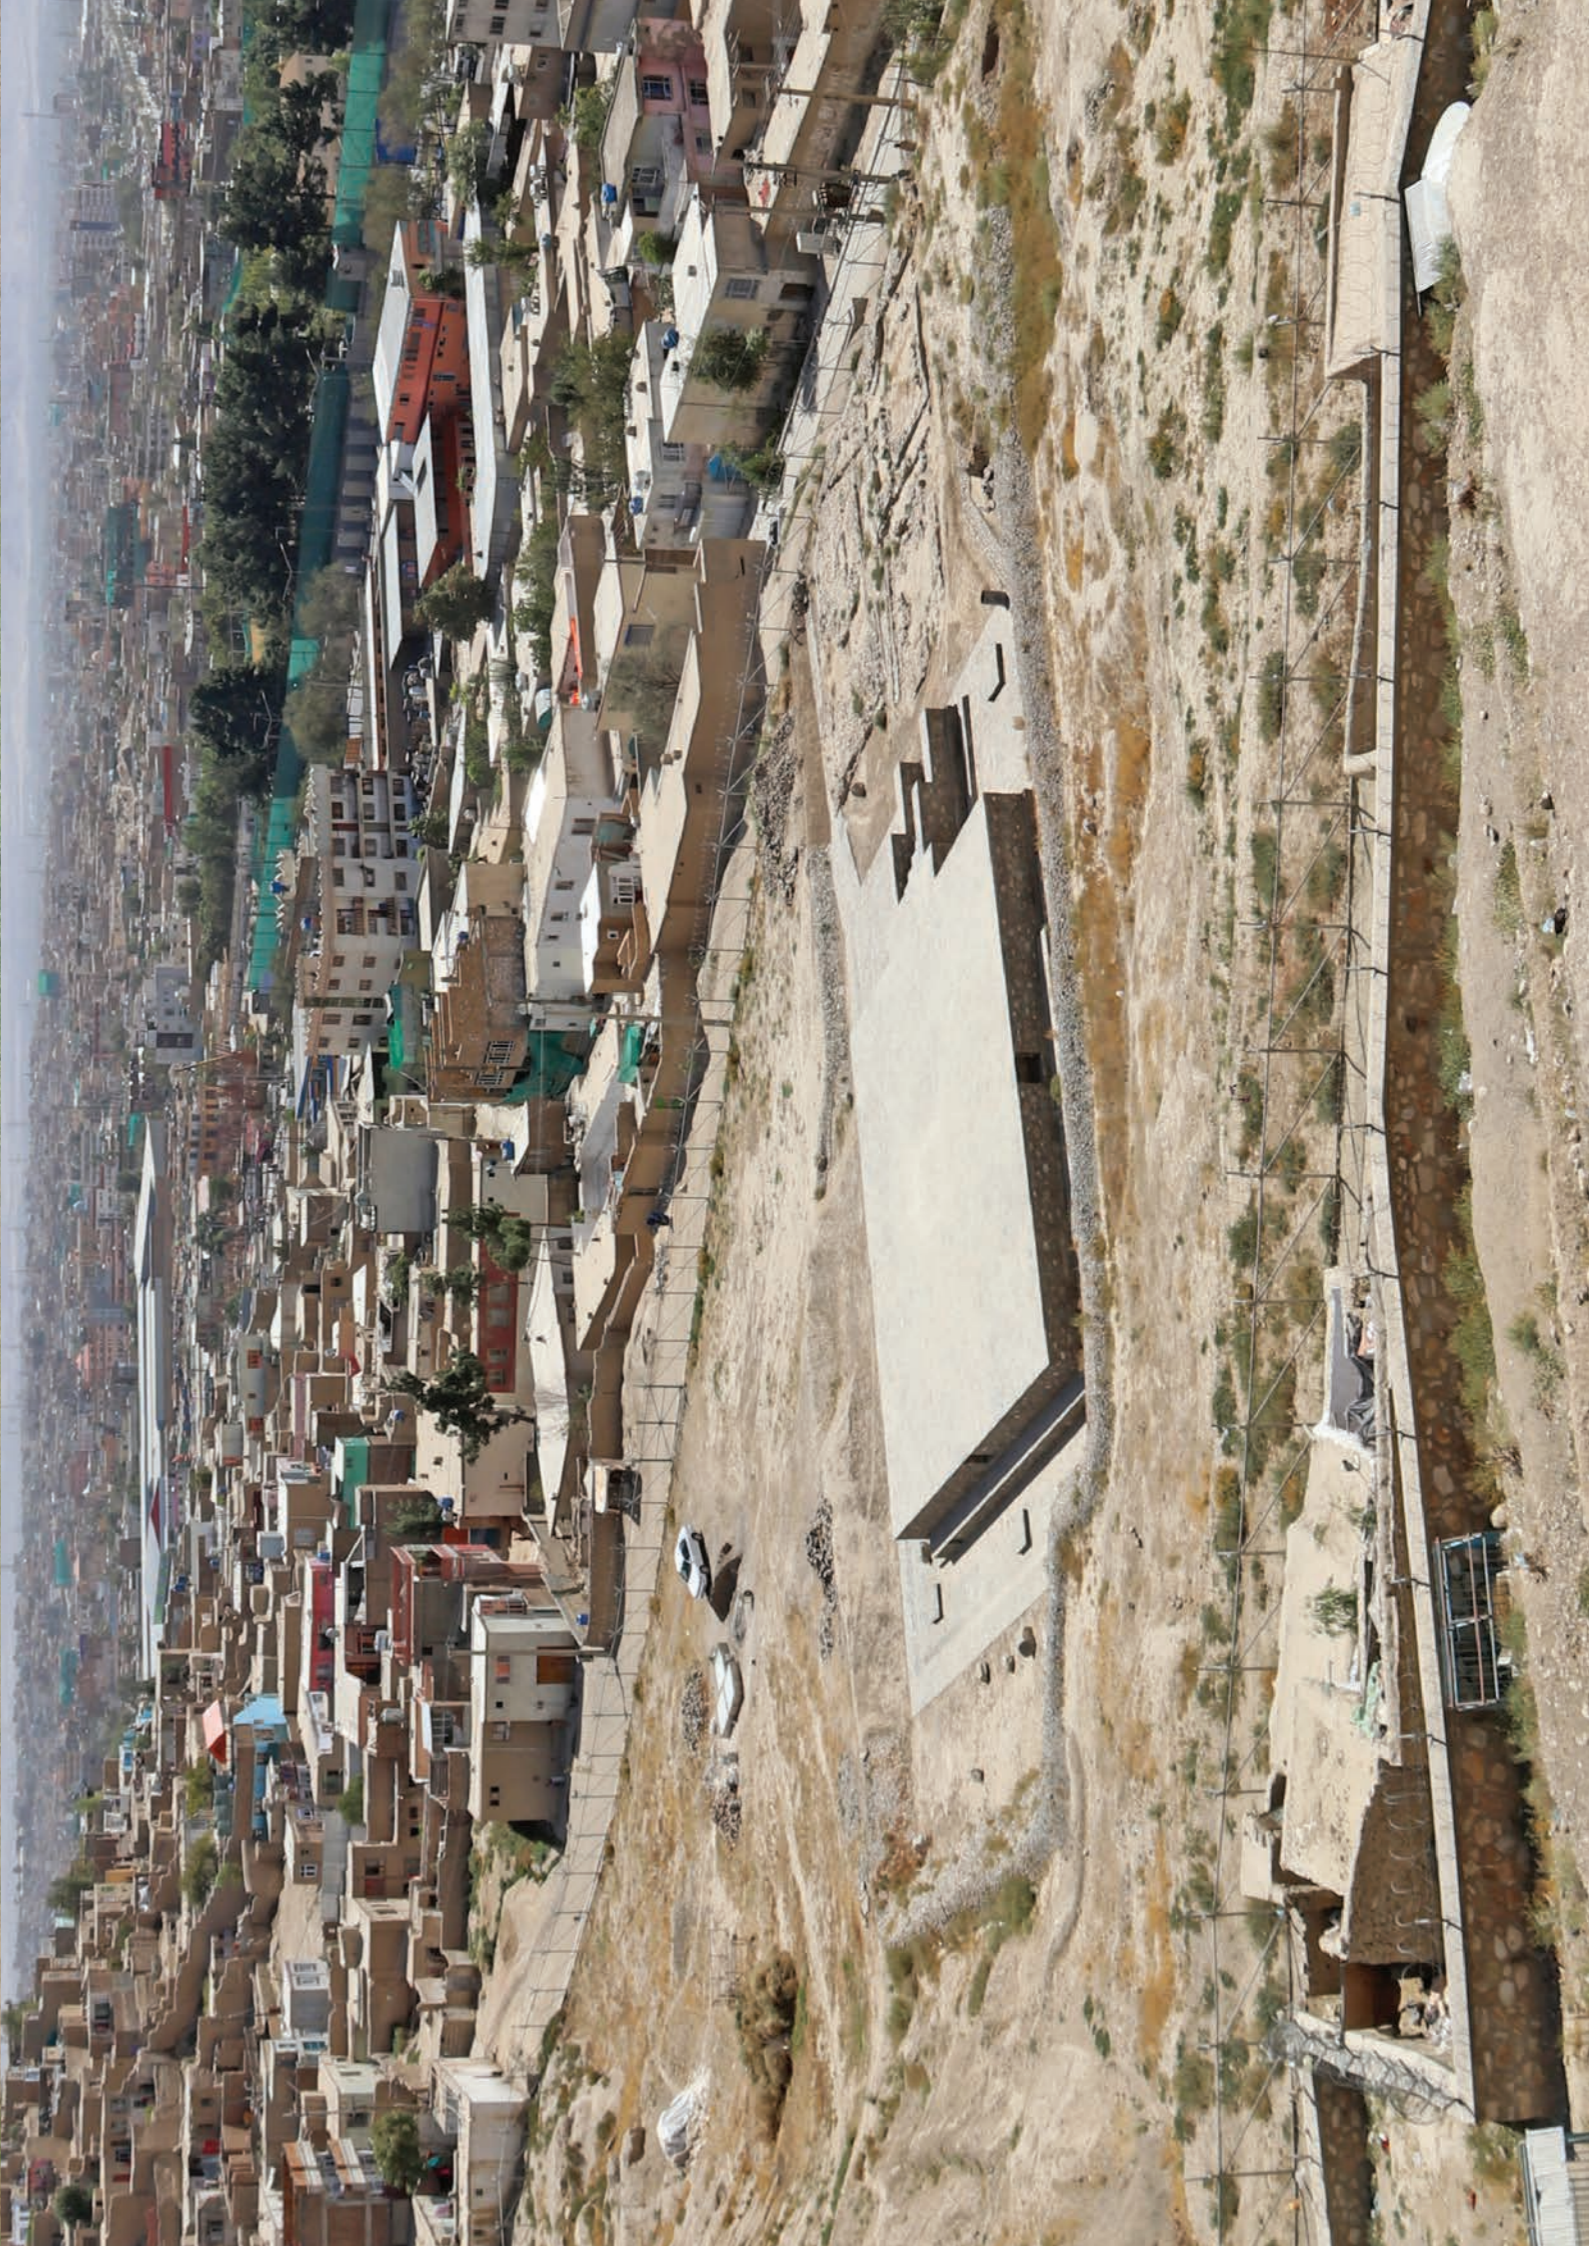
SOUTH ELEVATION, BEFORE CONSERVATION

SOUTH ELEVATION, AFTER CONSERVATION

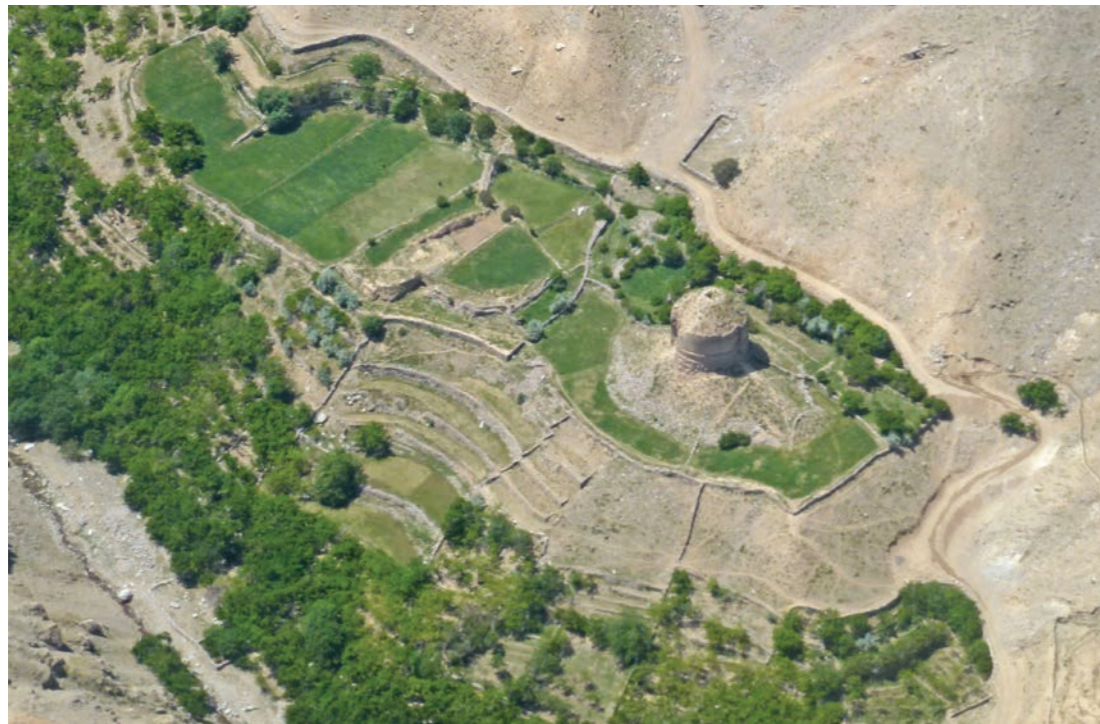
*Aerial view of Topdara stupa from south-west 2014*

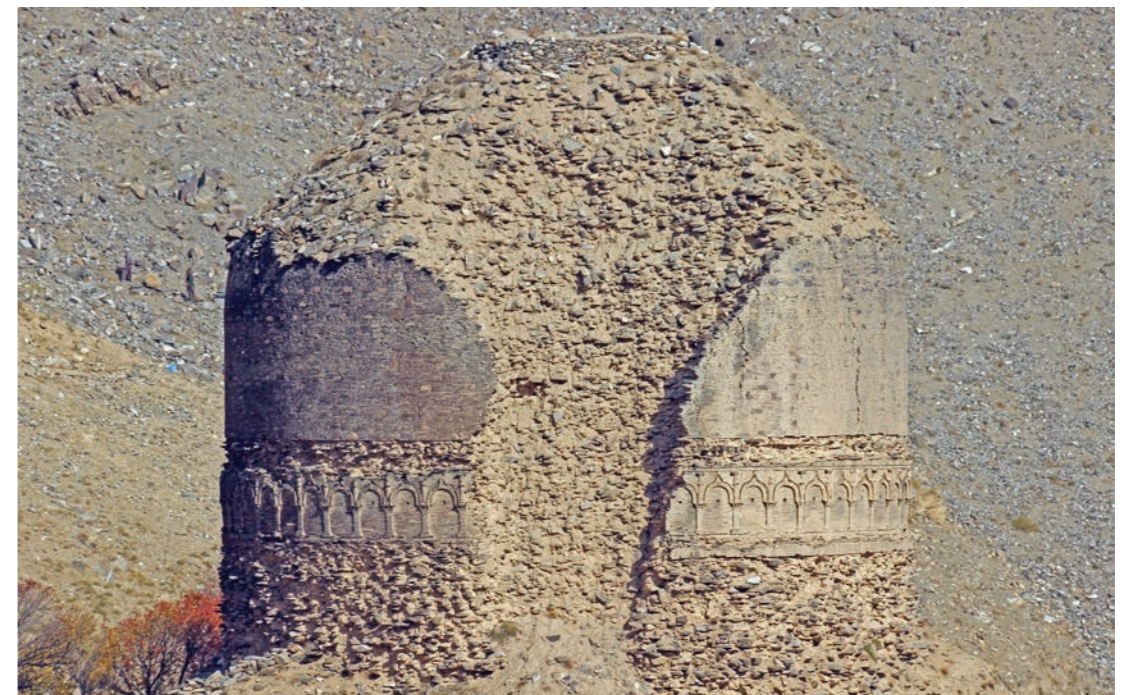
Initial surveys of the upper stupa at Topdara showed that a sizeable section of the south side had collapsed. The apex of the standing structure stood 33.12 metres above ground level, supported on a cylindrical drum measuring 20.8 metres in diameter. At this stage, the partially-collapsed dome and drum were the only visible parts of the structure, and stood on a steep mound of earth and rubble, with few indications of what might lie underground.

*Collapsed section of stupa drum and dome to south 2016*

To ensure the structural integrity of the structure, the focus of conservation activity then shifted to the collapsed section on the south side. Photographic records since the 1990s indicated that erosion of material in the core of the stupa had accelerated, risking a total collapse if left unchecked. Following removal of loose earth from the base of the damaged section, courses of stone infill were laid in lime mortar, using primarily material retrieved from the rubble that was keyed into the original masonry to ensure an effective structural bond.

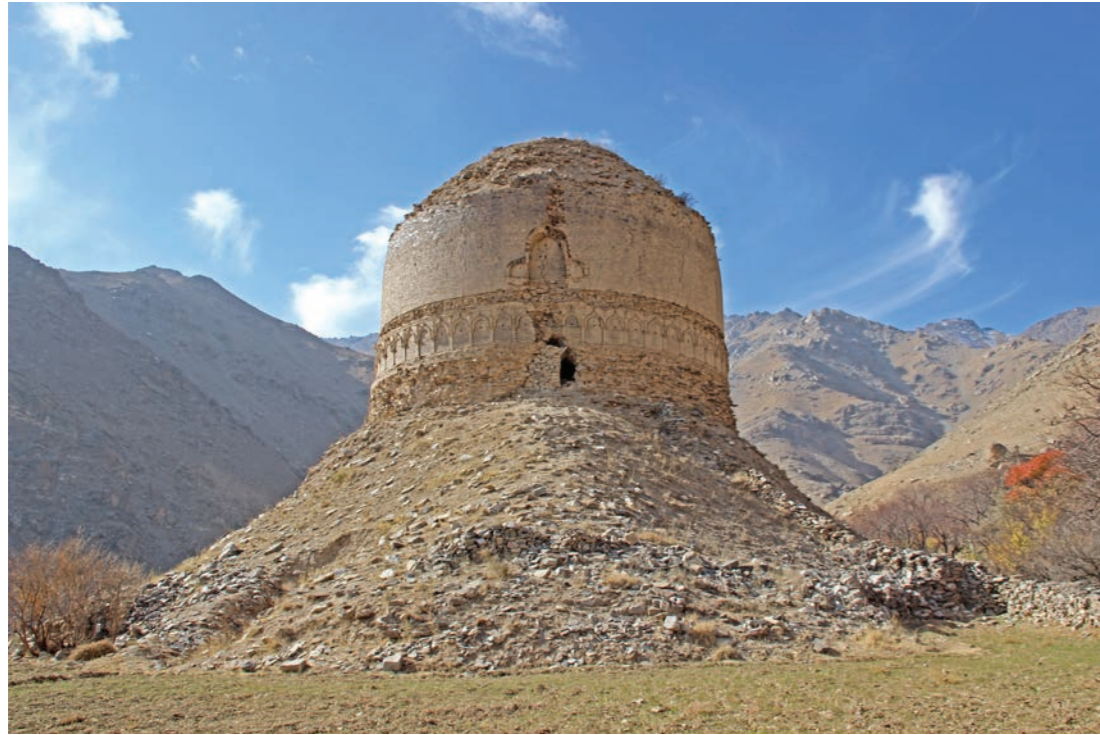
*Mound around the stupa, from the east 2016*

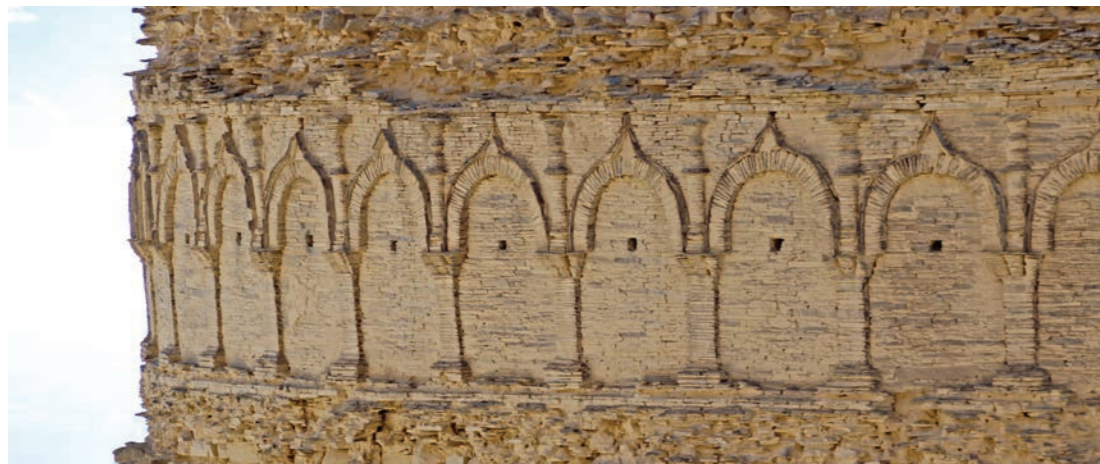
*Detail of arcade around the drum of the stupa 2016*

The upper part of the drum has an arcade comprising 56 blank arches (90cm wide) with projecting ogee-shaped hoods, divided by engaged piers with tri-partite capitals, the central section of which support cylindrical pilasters in the spandrels extending to an upper string course. Each bay of the arcade has a dowel hole that would have been used for fixing decorative panels or figures.

This was followed by repairs to the projecting cornice above the arcade around the drum, using surviving traces of the original masonry as a template. Unstable sections of masonry on the upper surface of the dome were also stabilized at this time, as material dislodged from above had over time damaged projecting elements on the lower structure (such as the cornice) as they fell.

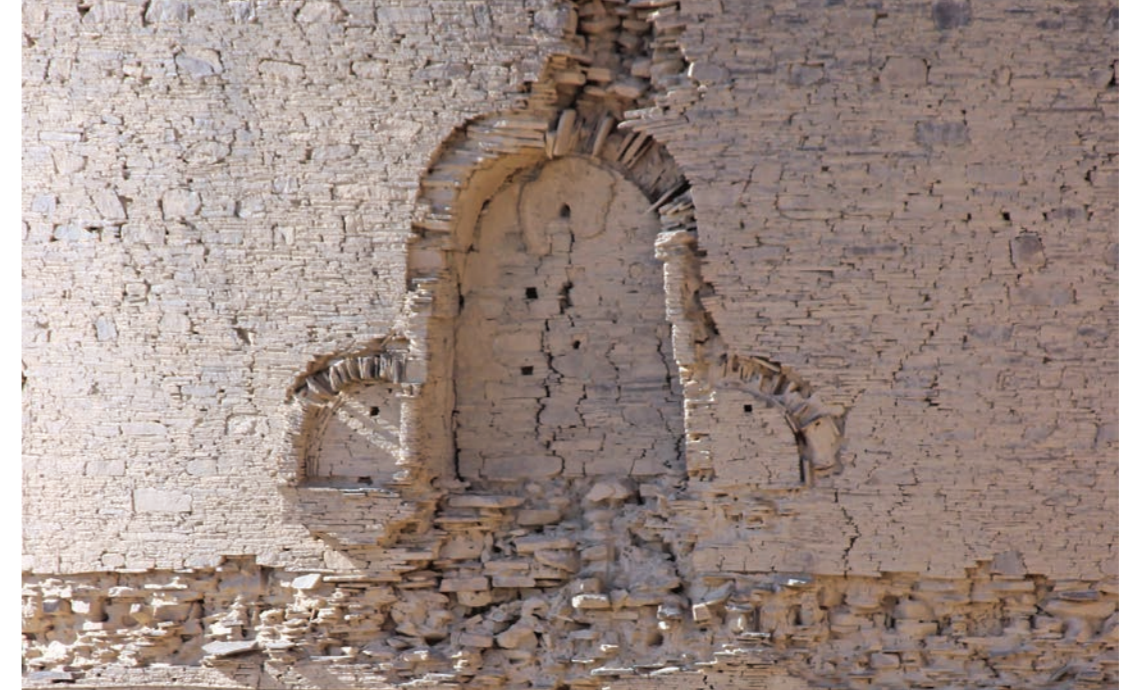
*Upper niche on the east side of the stupa drum, prior to restoration 2016*

At a higher level, on the east side of the drum, a deeper tri-lobed niche (measuring 4 metres across and 2.9 metres high) housed sculpture, probably a standing Buddha flanked by figures of donors. Traces of a stucco halo were recorded in this niche during a survey in 1972 (Mizuno).

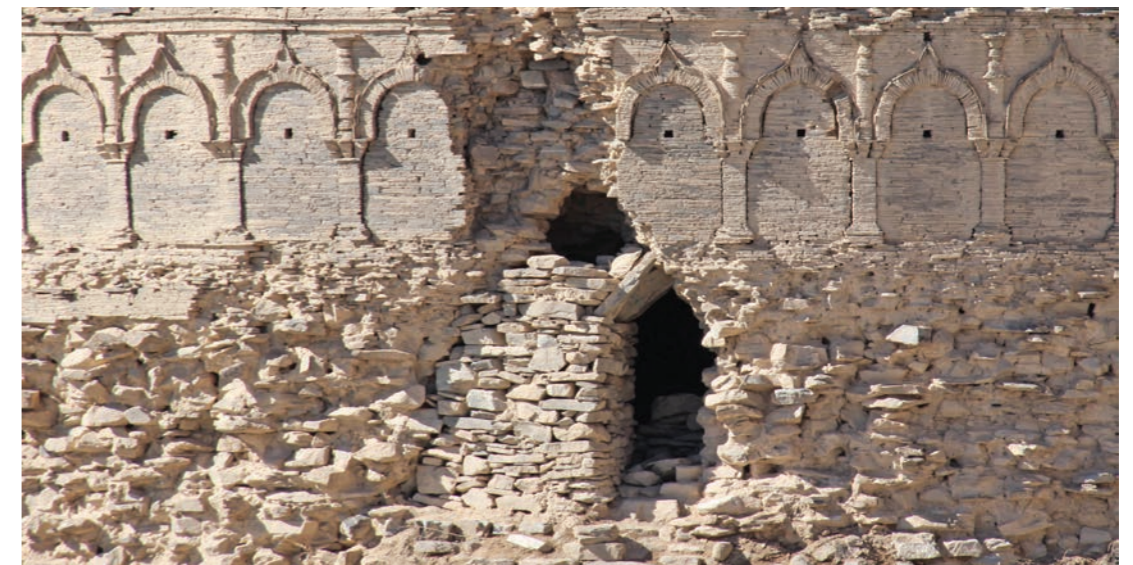
*Cavity on east side of the lower drum of the stupa, before filling 2016*

At the base of the drum on the east side was a sizeable cavity extending deep into the structure, the result of the ‘opening’ of the stupa in 1833 by the British adventurer Charles Masson, who in 1841 described the stupa thus:

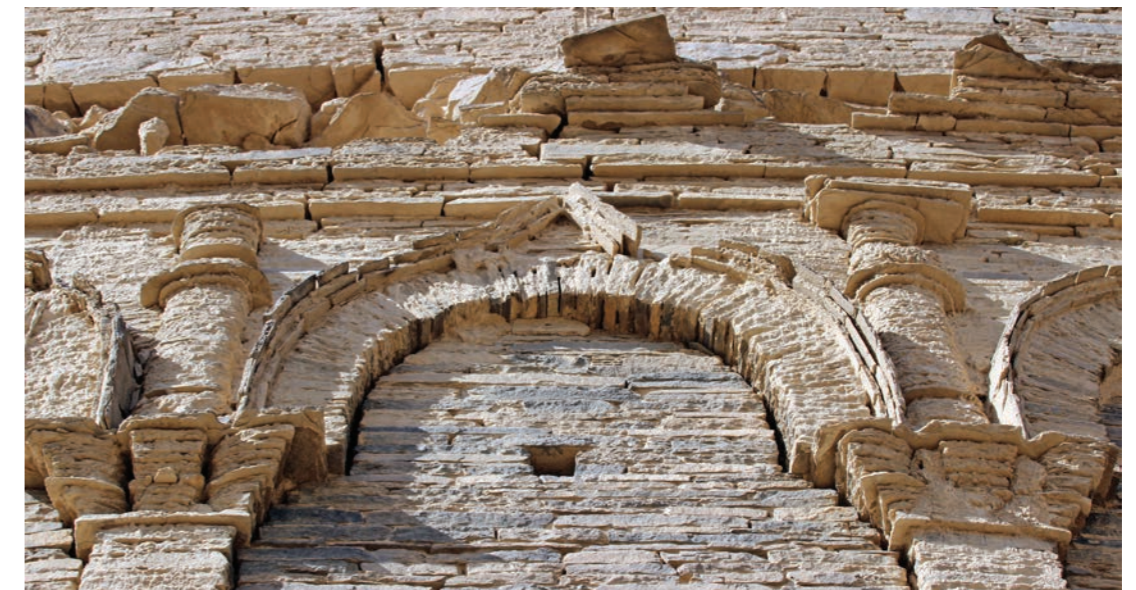
*Detail of arch in the arcade around the stupa drum 2016*

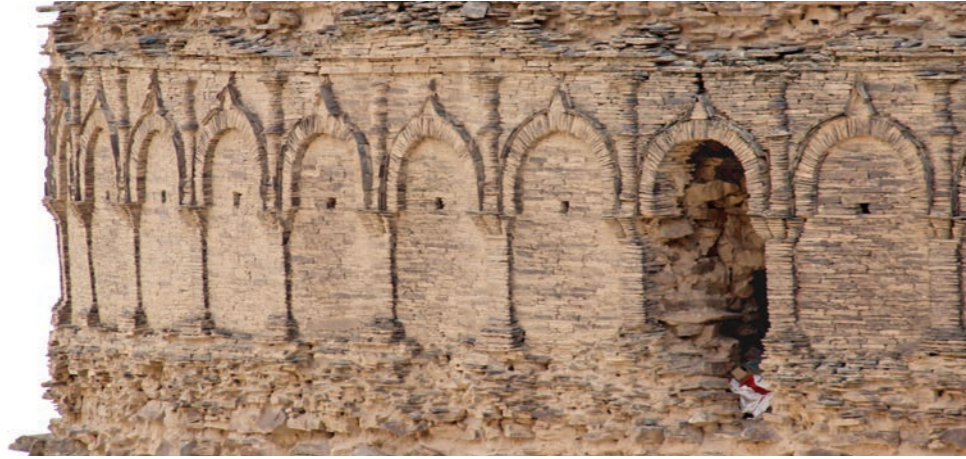
A cavity that had been opened in a north-facing niche of the arcade – in all likelihood also the work of Charles Masson, who wrote of his frustration at failing to locate a reliquary at a lower level – was also backfilled with stone laid in lime mortar.

*Cavity on the north side of the arcade around the drum 2016*

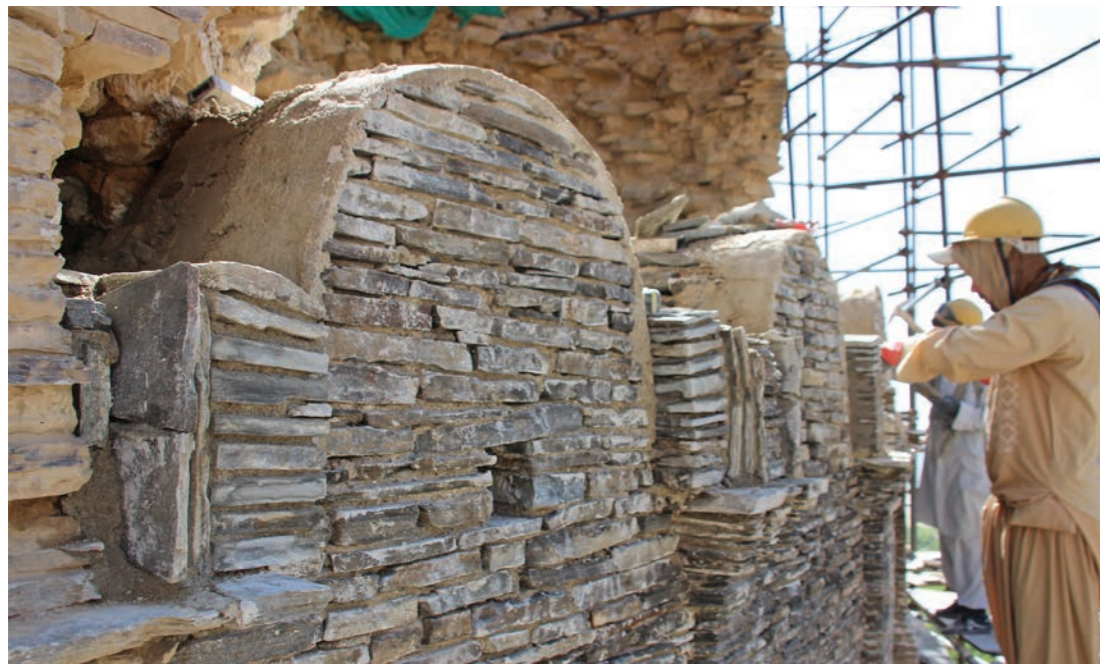
*Reconstruction of collapsed section of the arcade around the drum 2017*

Once the reconstruction of the lower drum reached the level of the arcaded band, 5 missing niches were rebuilt in a manner matching the original scheme, while repairs were undertaken to the damaged upper tri-lobed niche on the east side described above. As in subsequent interventions, infill masonry here was laid with a 3 cm projection, to enable these sections to be distinguished from the original fabric, in line with international conservation practice.

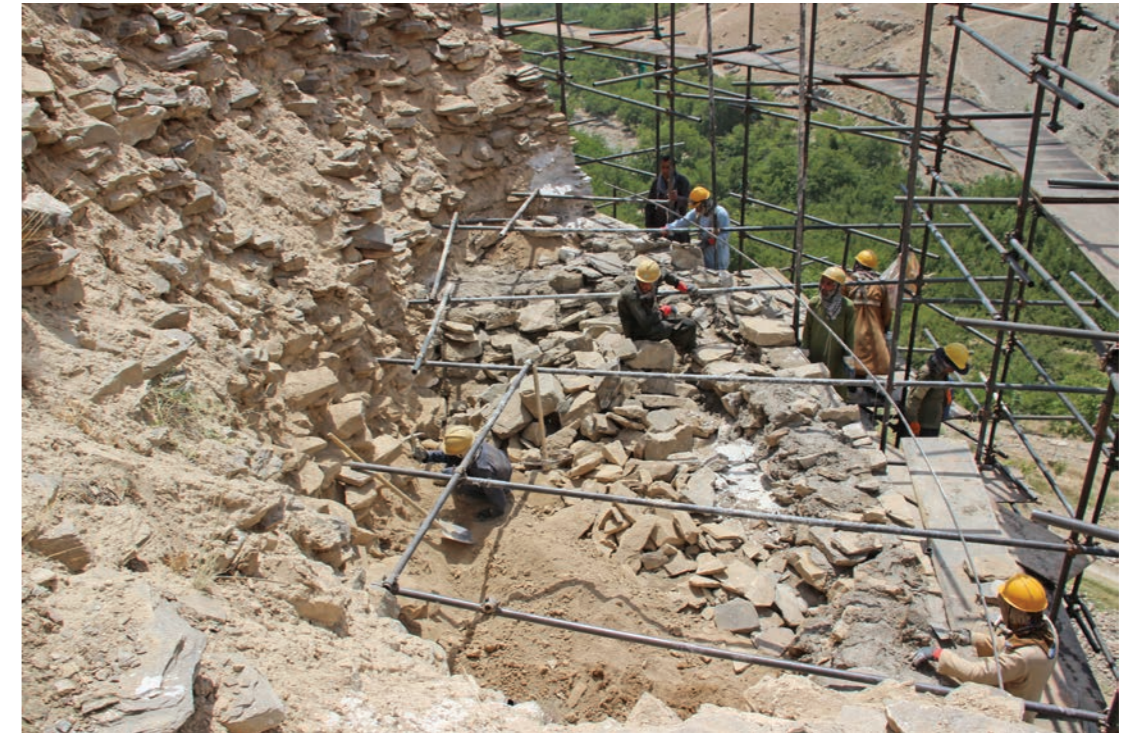
*Laying masonry infill during repairs to the stupa dome 2017*

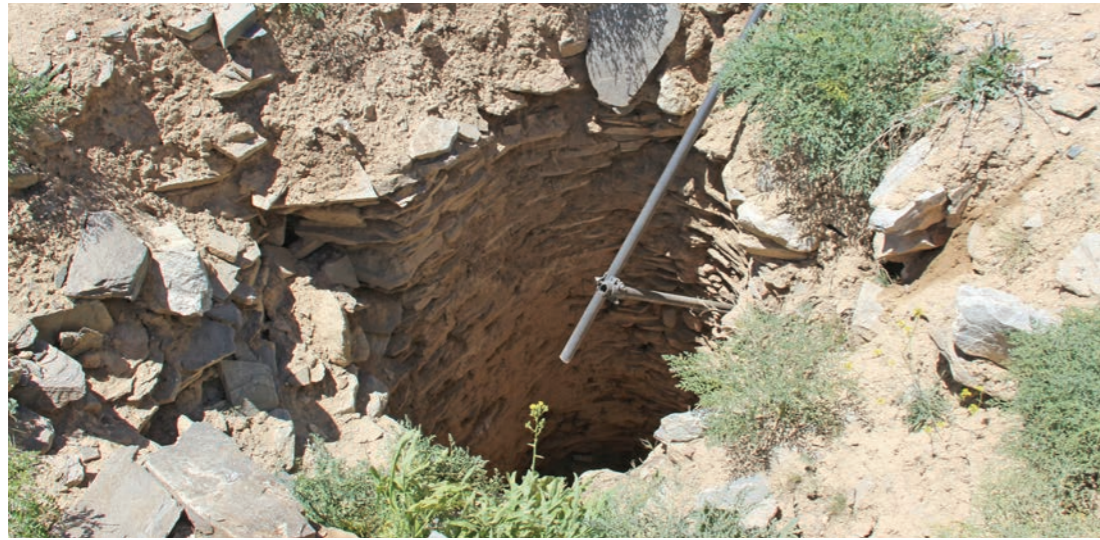
With the structural base of the stupa strengthened, a detailed inspection of the surface of the dome was undertaken, revealing a cylindrical well-like cavity at its apex, measuring 1.2 metres across and some 3.2 metres deep. The nature of its construction indicates that it may have formed part of a reliquary, as seen on some other stupas from this period. Villagers from the area however claim that the cavity was dug by snipers during factional fighting in the area during the 1980s, when it provided a vantage-point. After documentation, the cavity was closed off with a small stone dome in order that work might proceed on backfilling the core.

*Cavity in the apex of the stupa dome, prior to capping 2017*

The reconstruction of the dome was undertaken entirely manually, with some 4,600 tons of stone (some of which was quarried from nearby mountains) lifted by hand up scaffolding that had been erected around the structure. The infill was laid in a clay-rich mortar, matching the original un-coursed masonry, with the profile of the dome based on geometry derived from the surviving parts. The dome surface was finished with diaper stone with pointing of lime-rich mortar.

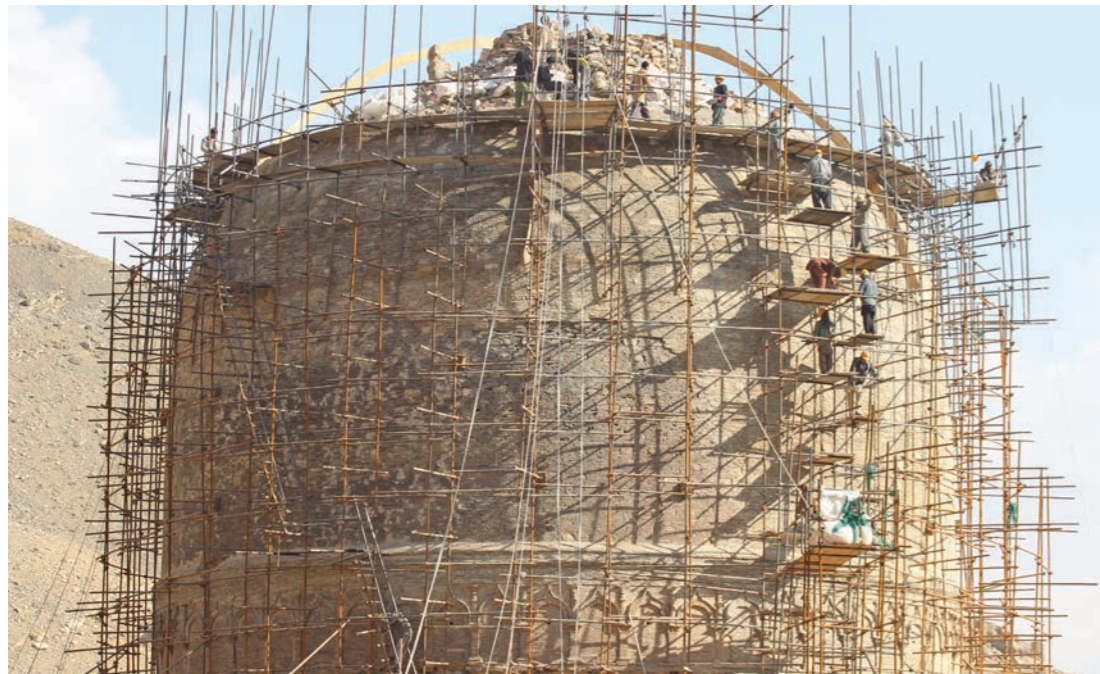
*Reconstruction of the stupa dome viewed from the west 2017*

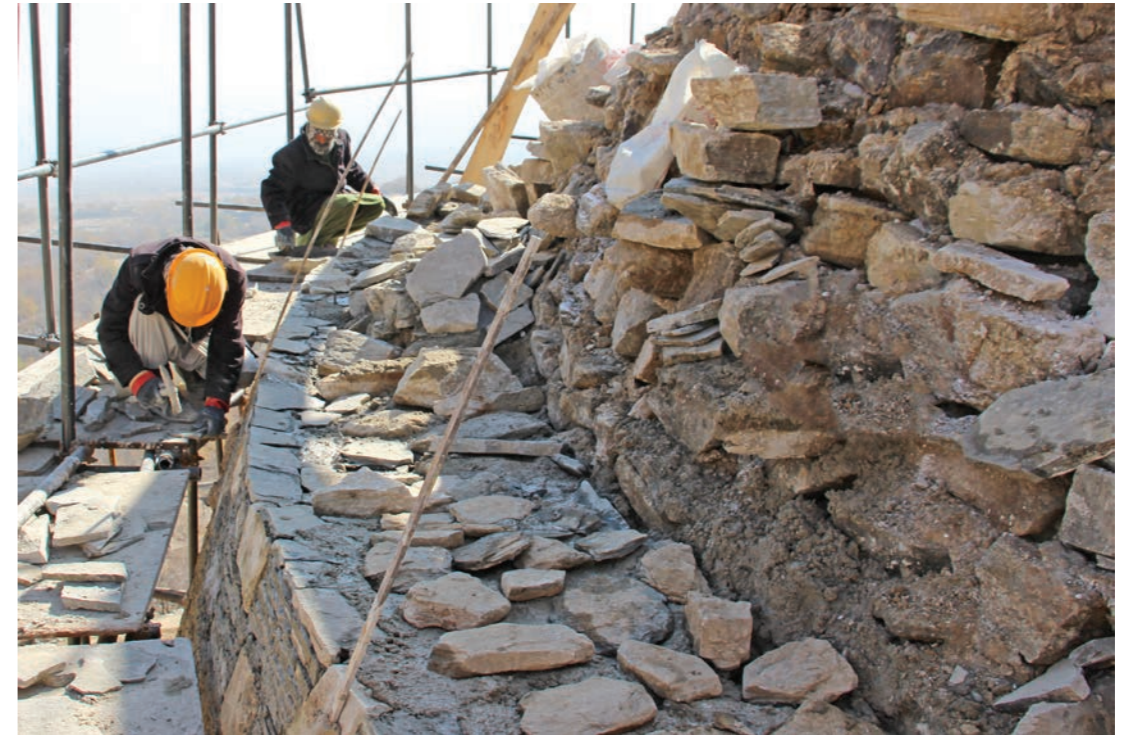
*Laying masonry around the outer edge of the dome 2017*

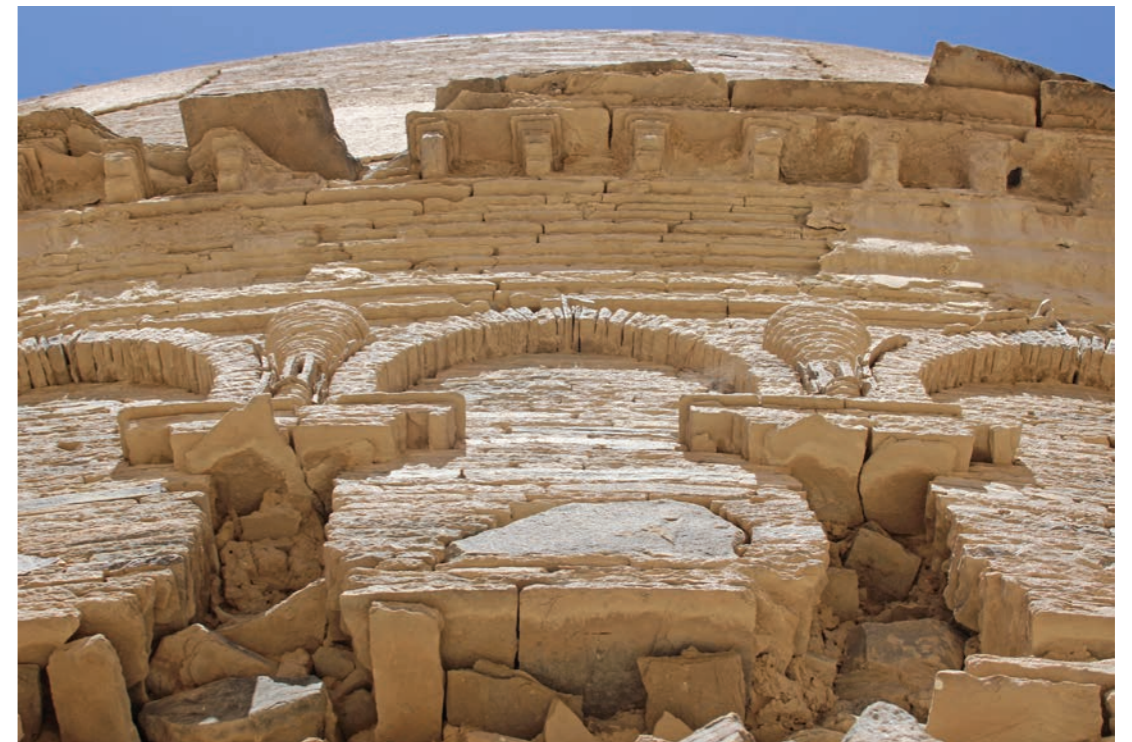
*Detail of cornice (from below) at stupa 1 at Shewaki 2020*

Little of the cornice that ran around the lower edge of the dome (above the arcade) remained, as material dislodged from above had obliterated any protruding elements. Other stupas that retain this cornice intact (Shewaki, for example) suggest that it was likely to be an elaborate configuration made up of cantilevered pieces of schist. In the absence of traces of any such detail at Topdara, a conjectural reconstruction was avoided and this zone simply stabilized with plain masonry infill.

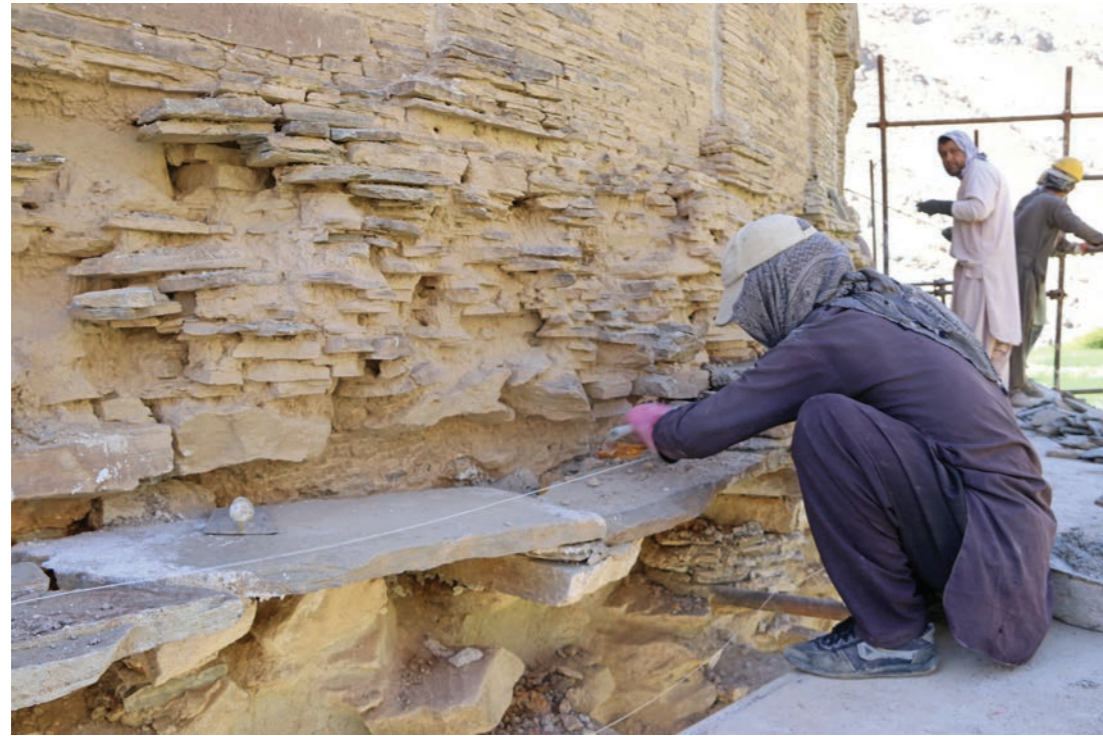
*Cantilever for lower string course under construction 2018*

Below the arcaded band around the drum, however, the original details of a lower string course could be discerned, and these were stabilized and partial reconstruction undertaken of the missing sections. On the north side, where weather-related deterioration was most severe, a cantilevered section was constructed to support masonry of parts of the string course that had collapsed.

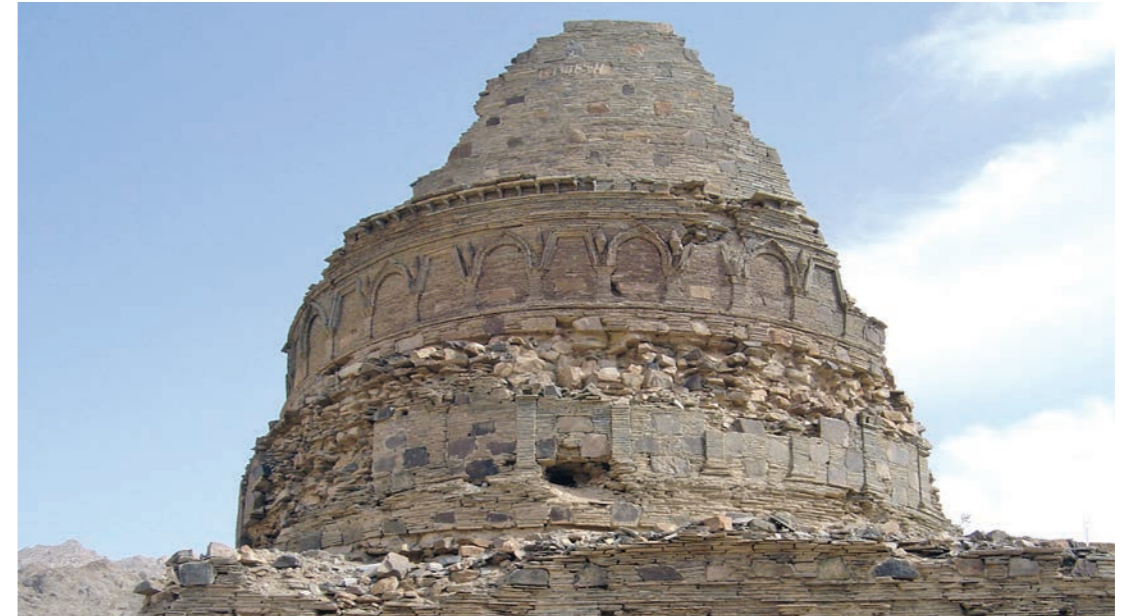
It is unclear why no trace remained of the architectural treatment of the lower drum, where there is a band of rough stone masonry above an articulated base. Other stupas of this era, such as Guldara, have a series of engaged piers around the lower drum, and it is likely that Topdara had a similar treatment.

*View of the stupa drum at Guldara 2004*

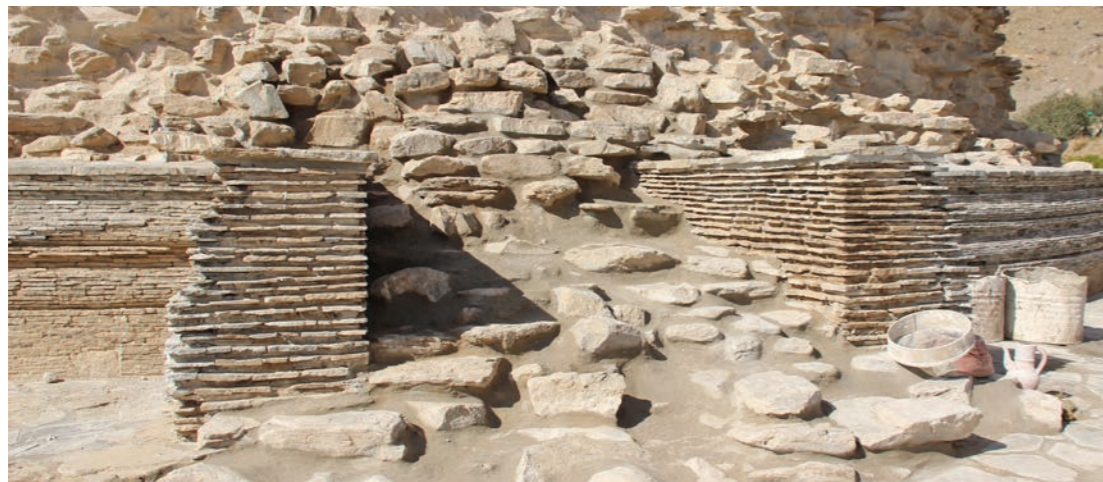
*Upper stair on the east side at Topdara, after stabilization 2019*

The remaining traces of the articulated projecting base (1.5 metres high) around the base of the lower drum provided a template for reconstruction, along with a short flight of steps (measuring 3 metres across) on the east side, from the platform level up to the drum, aligned with the tri-lobed niche above. Flanked by low walls, this flight of steps is likely to have had a ritual function.

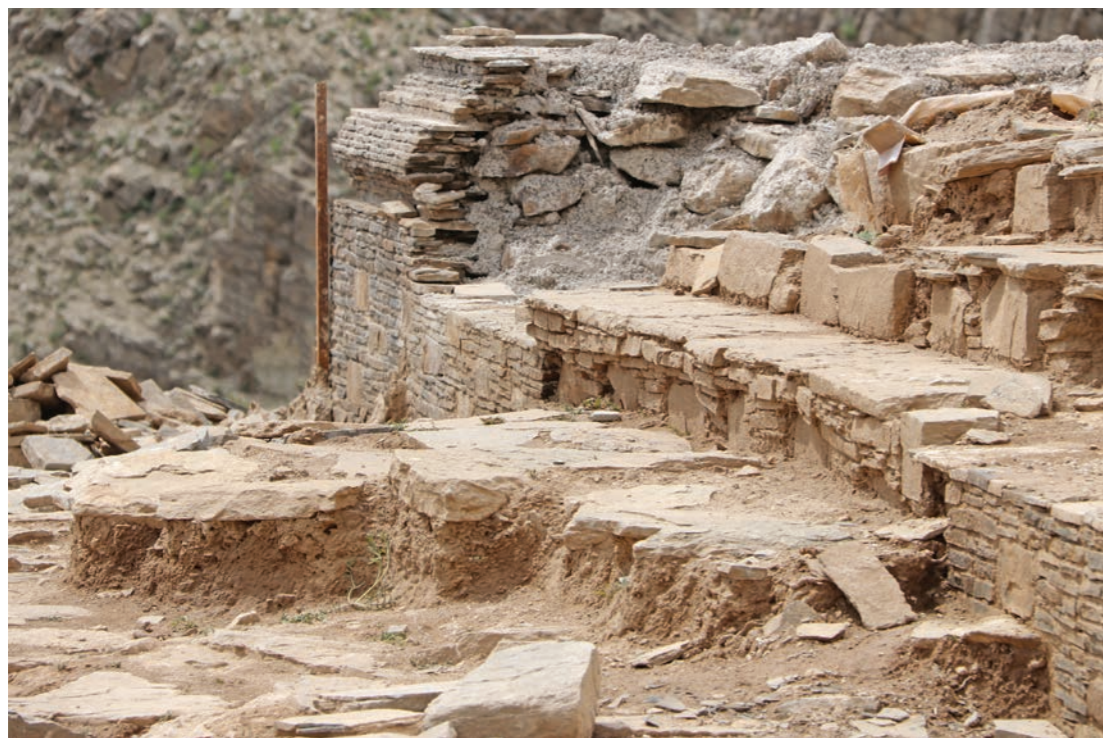
*East stair at Topdara, prior to reconstruction 2018*

As conservation of the dome and arcade proceeded, excavation of material from the east side revealed sections of the original masonry of the walls flanking a staircase measuring 10 metres across and extending for 19.5 metres from the stupa platform, to which it provides access from ground level. Several of the original steps were found intact at the lower level and these formed the basis for the subsequent reconstruction of the entire flight of stairs, comprising 50 steps with risers of 20 cm and treads of 38 cm. As no trace was found of the original parapets of the flanking walls, these were left unfinished.

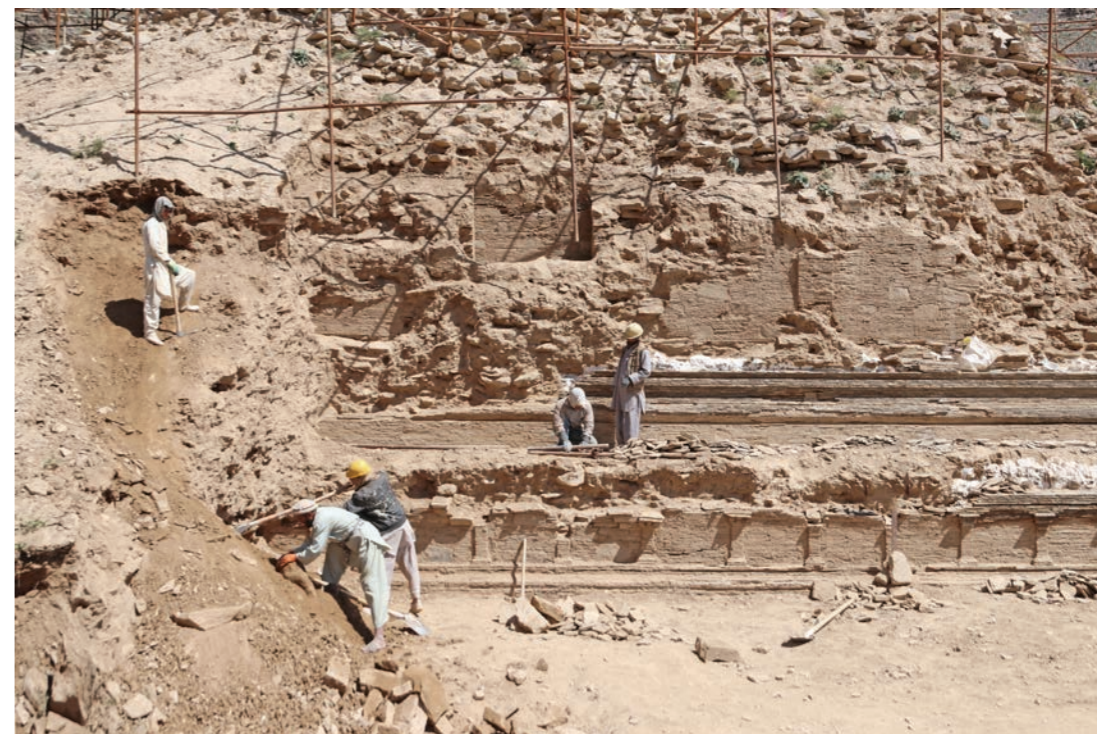
*Excavation along south side of the plinth and platform at Topdara 2017*

Subsequent excavation along the south side of the platform revealed extensive sections of the original masonry intact at lower levels, and the documentation of these informed the ensuing process of stabilization and conservation.
