# CONSERVATION OF TEPE MARANJAN & TOPDARA, AFGHANISTAN 2016-20

AFGHAN CULTURAL HERITAGE  
CONSULTING ORGANIZATION

**CONSERVATION OF  
TEPE MARANJAN & TOPDARA  
AFGHANISTAN 2016-20**

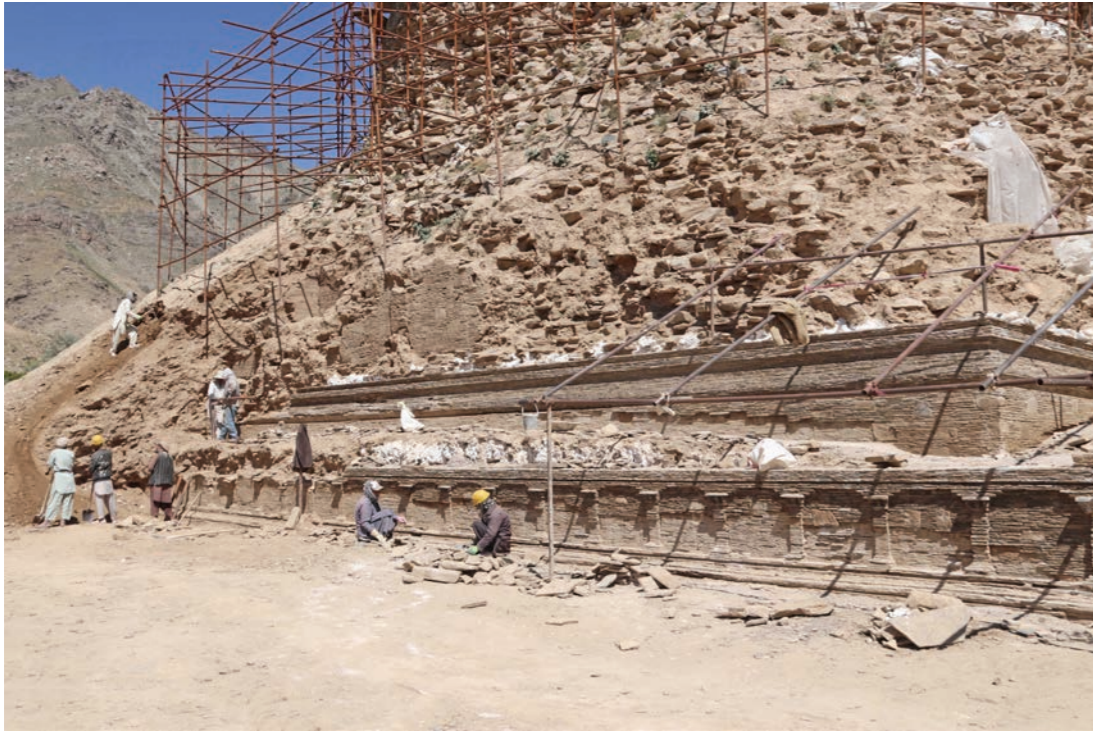
*Initial stabilization of the south side of the plinth and platform 2017*

The strategy adopted for the conservation of this and other excavated masonry was to document and then stabilize the original sections in situ, using stones retrieved from the rubble and laid in lime mortar. Deflections or distortion of the original sections was where feasible incorporated into the repairs, with areas of new infill masonry laid with a 1 cm protrusion to enable it to be distinguished from the original fabric, as described earlier.

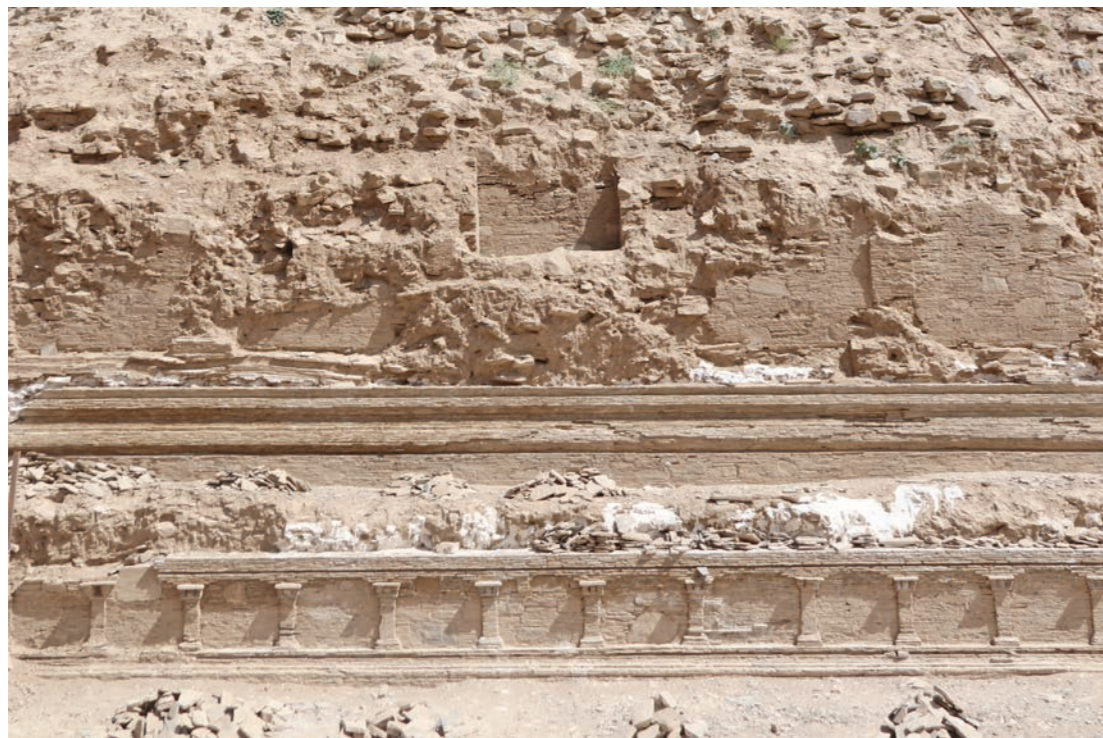
*Excavated plinth and platform masonry on south elevation, with niche 2017*

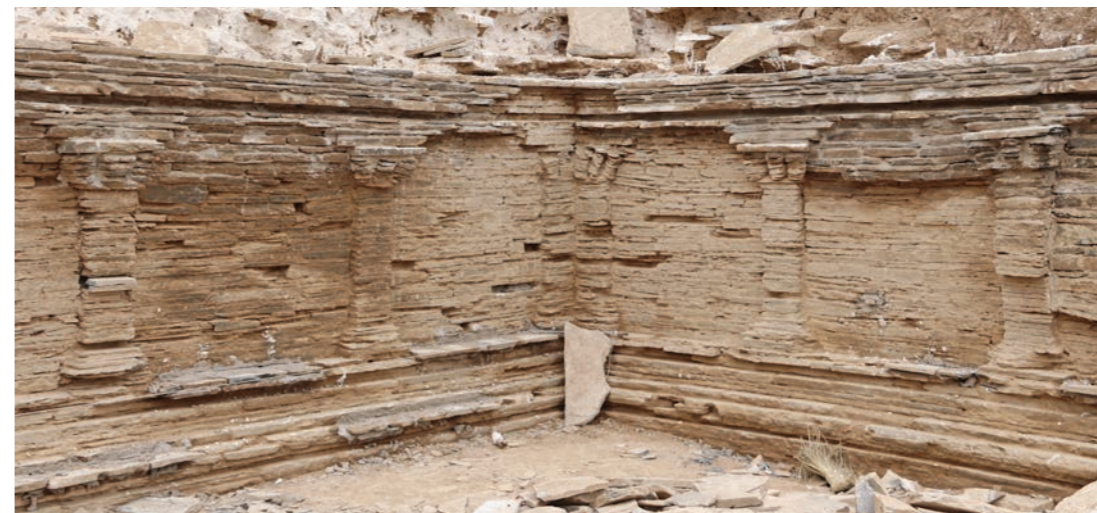
*Detail of original masonry (lower part) and infill above on plinth 2017*

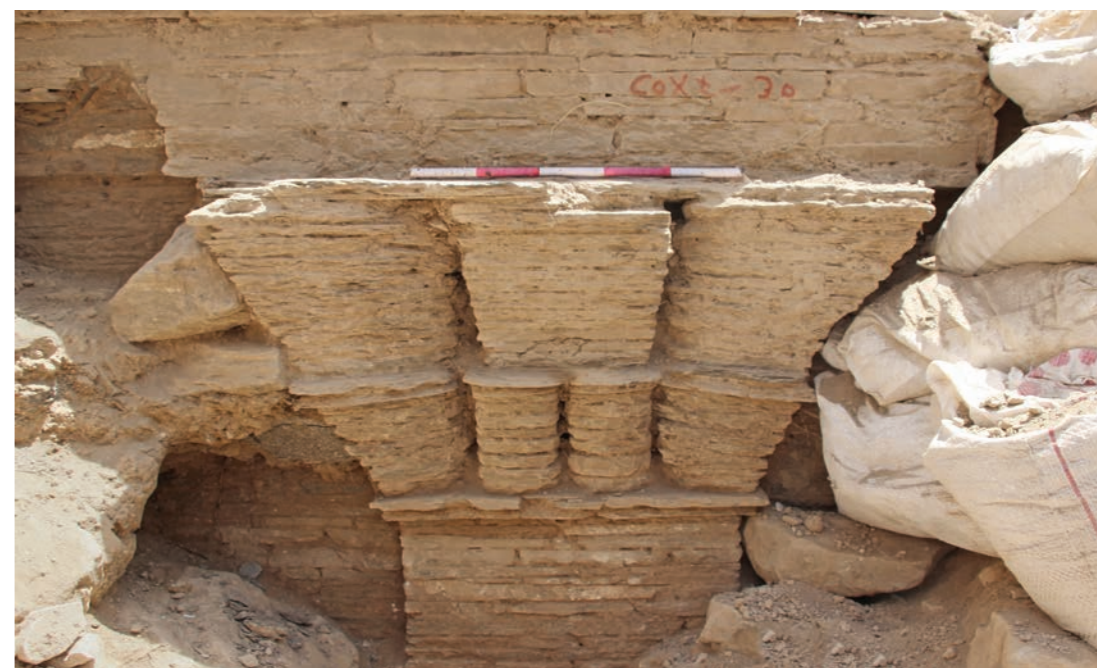
The condition of the original masonry on both the plinth and platform of the stupa indicate that its deterioration was a consequence of neglect, with no evidence of deliberate destruction. The upper part of the west elevation was better-preserved than elsewhere, due to the addition of a stair that abuts and thereby offers protection to the platform, where 3 capitals of the engaged piers survived and served as a template for reconstruction on other elevations.

*Detail of excavated capital on west elevation of platform 2018*

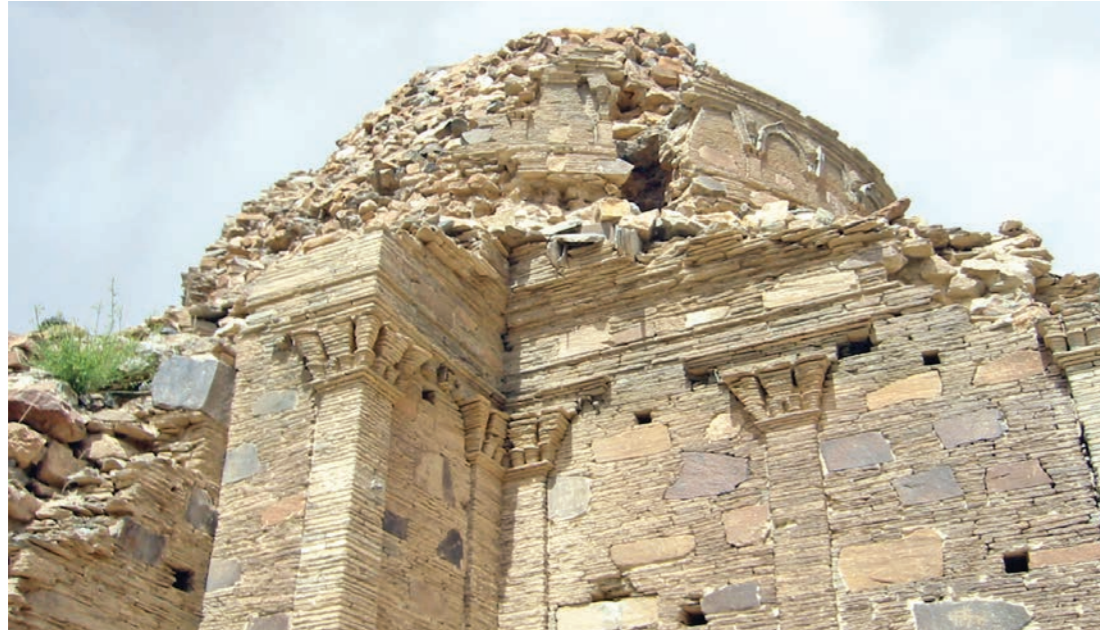
While there was no trace of the original architectural treatment of the upper part of the platform elevations, there would in all likelihood have been an elaborate entablature with a projecting cornice and architrave, as seen on other stupas (such as Guldara). Rather than undertaking a conjectural reconstruction, a band of indented masonry was built to indicate its unfinished condition.

*Remains of entablature on platform of Guldara stupa 2004*

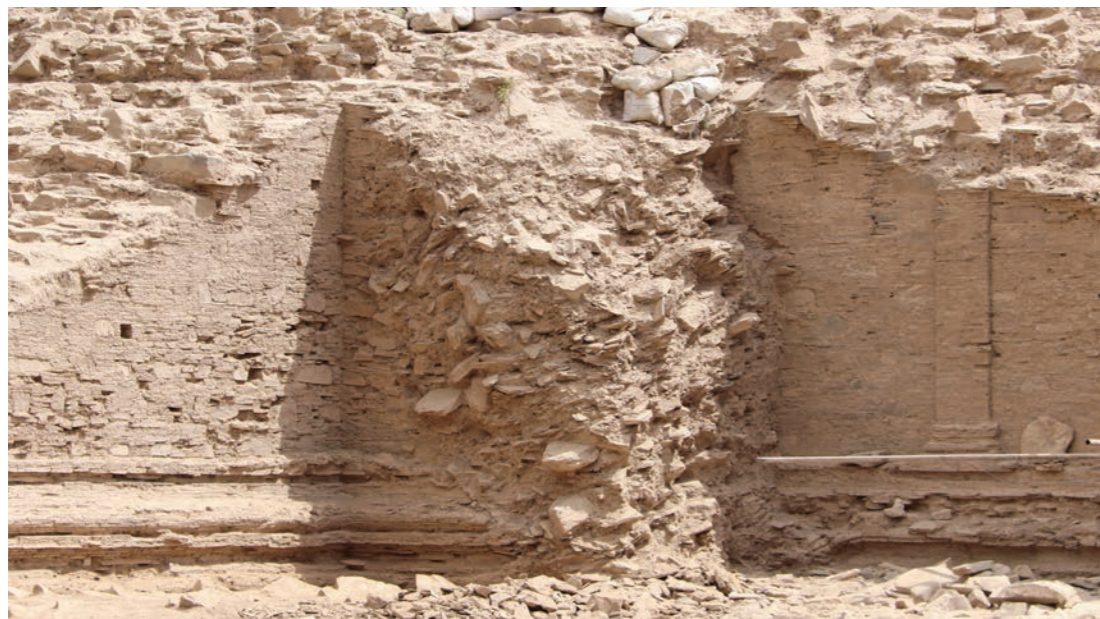
*Buttress on west side of stupa platform at Topdara, before stabilisation 2018*

The near-identical architectural treatment on three of the platform elevations provides evidence that the stair to the west (measuring 14.35 metres across and extending for 22.55 metres from the platform) was added subsequently. This is borne out by the lack of structural bonding with the platform masonry. At the junction of the stair and platform are full-height buttresses whose function is evidently structural; the depth of accumulated earth and rubble in this area indicate flash-flooding down an alluvial wash to the north-west that is currently planted as an orchard.

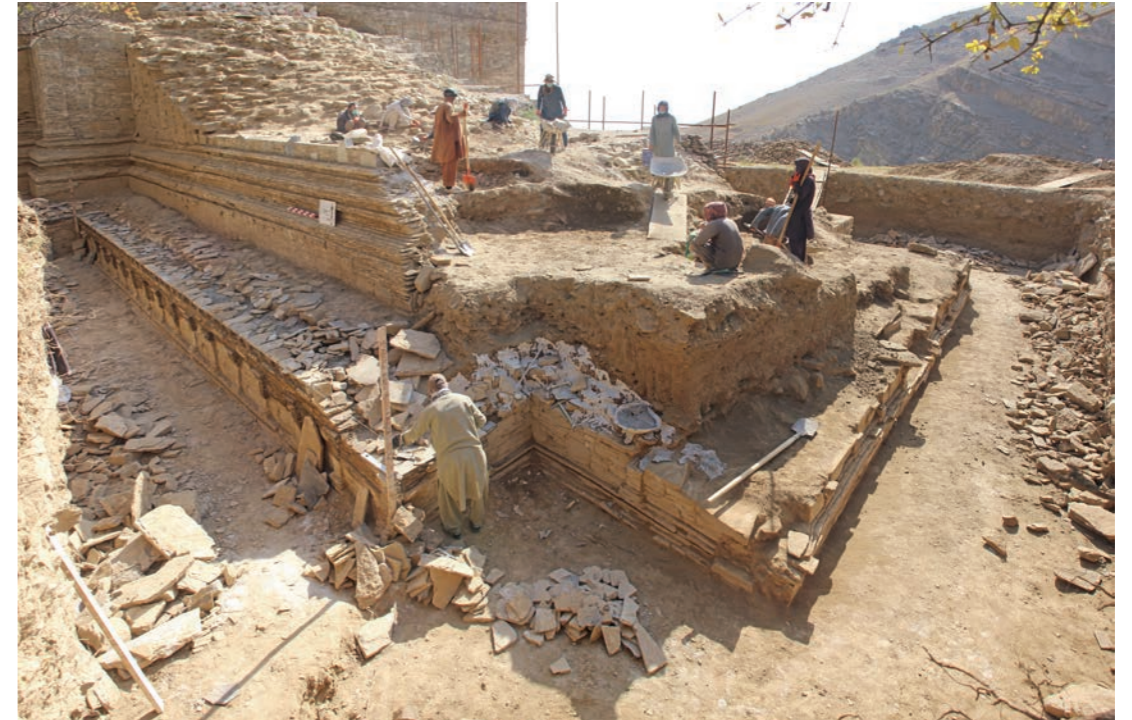
*West stair at Topdara during restoration 2019*

As no trace was found of the original risers or treads on the west stair, reconstruction of the steps was not attempted, with the surface finished with lime mortar to limit erosion. The lower parts of the plinth around the stair were in relatively good condition and were conserved, along with the flanking walls.

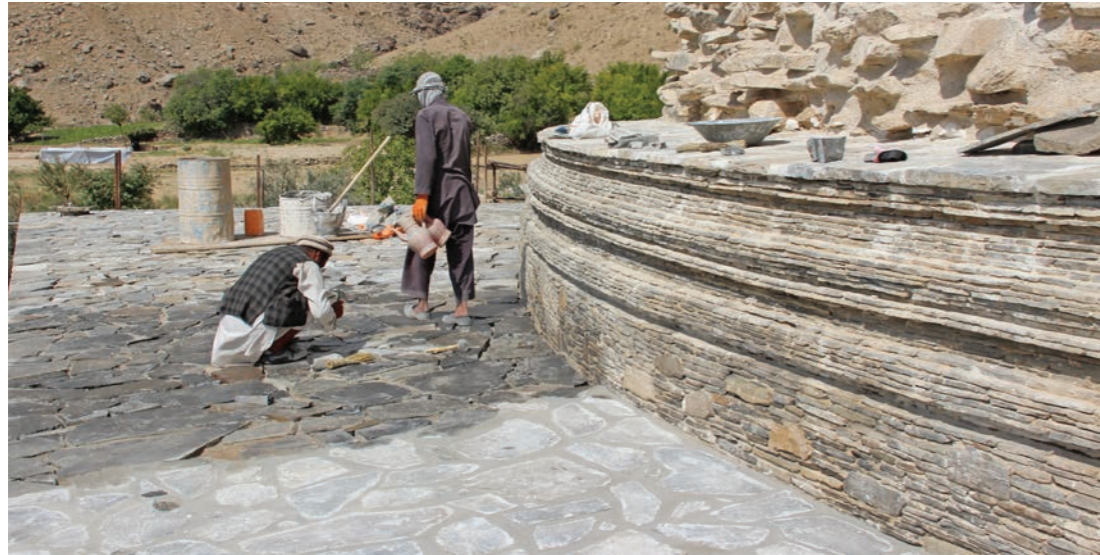
*Paving stone paving over the surface of the platform and ambulatory 2019*

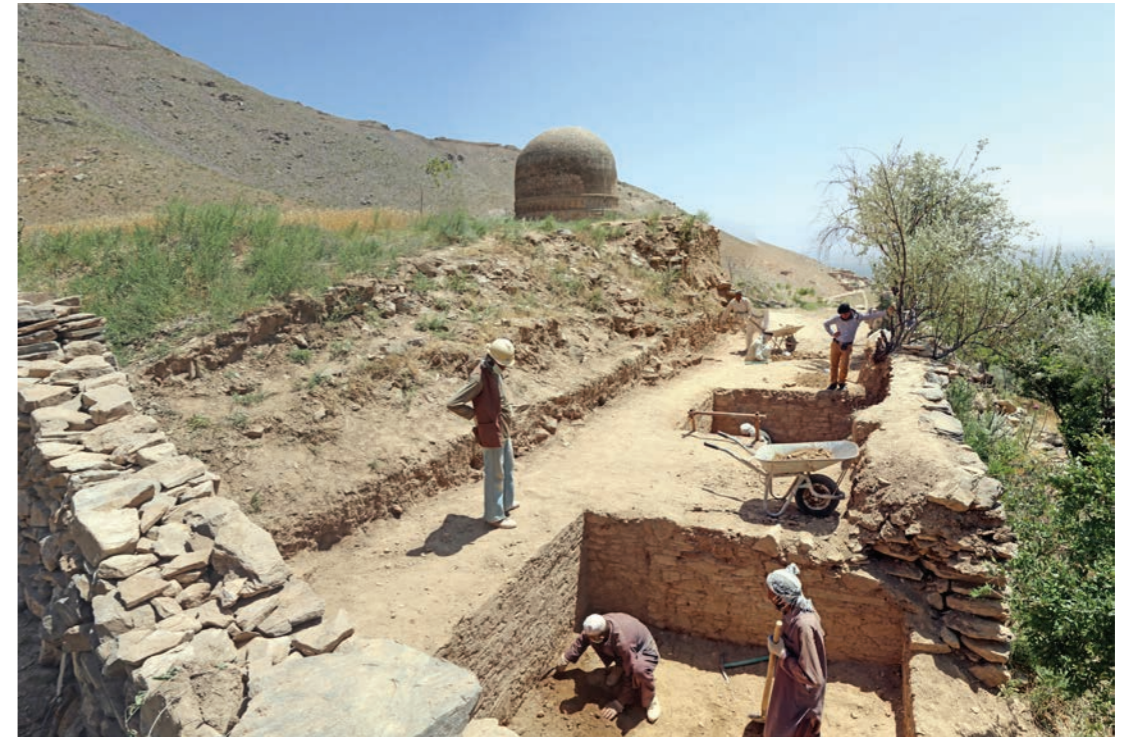
*Excavation of subterranean spaces on south edge of monastery 2019*

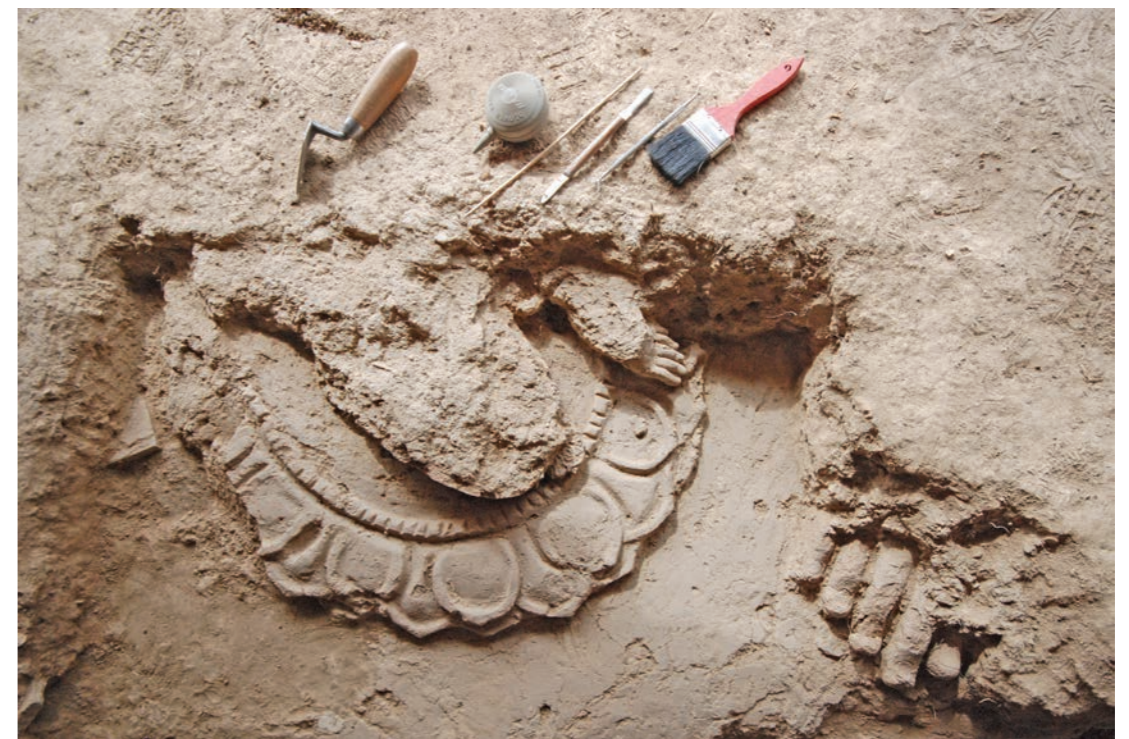
*Detail of stucco plinth and fragment of figurative sculpture 2019*

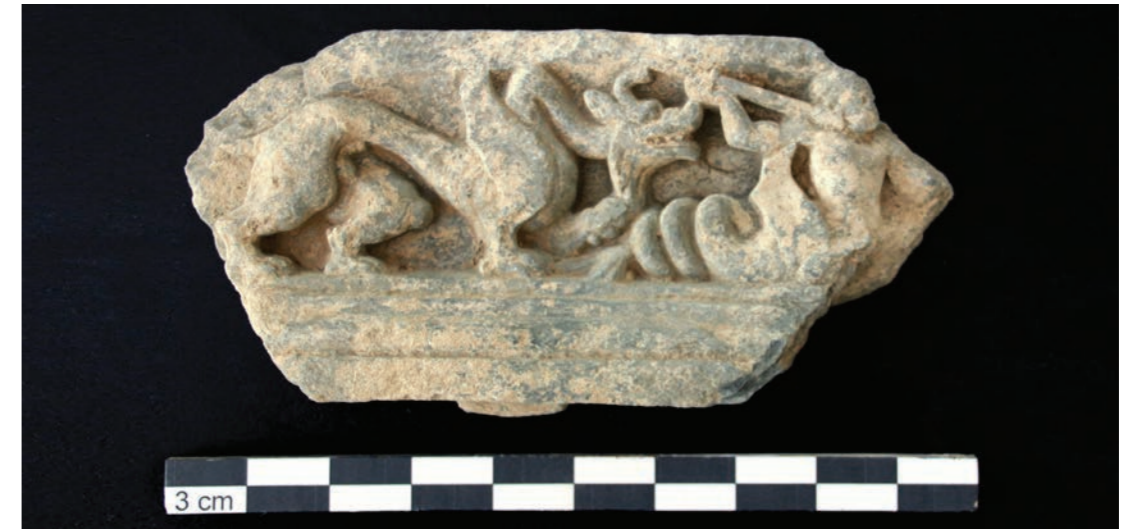
Two of these fragments seem to depict narrative scenes: one shows a seated figure of Patanjali (on the right) represented with a human torso and a lower body as coiled serpent, wielding a staff and facing a griffin-like creature. Believed to have been the author of the Yoga sutras around 400 C.E, Patanjali is represented elsewhere with a conch or a disc.

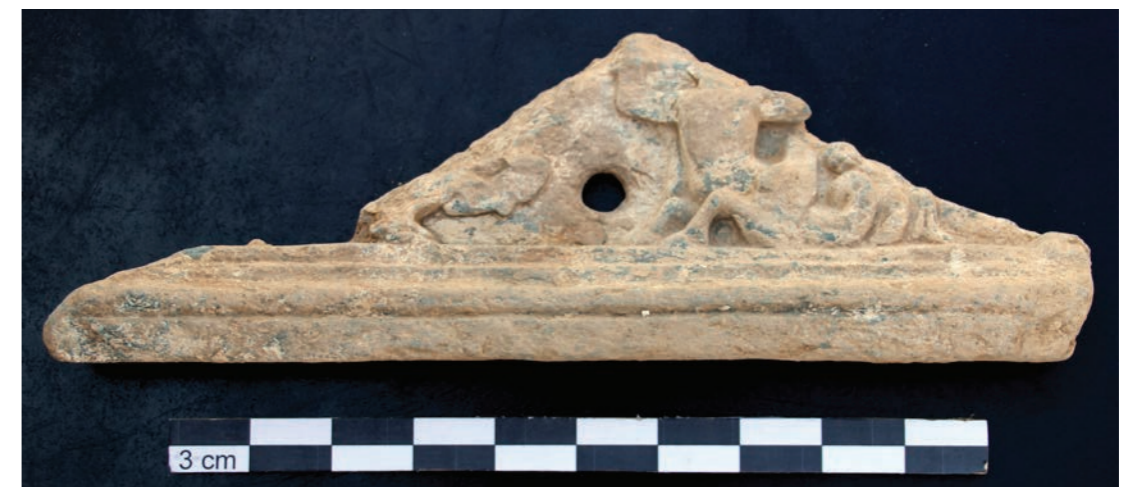
Another narrative schist fragment depicts a prone (female?) figure behind whom squats a male with arms outstretched, facing away. The figures on the left of the central hole (for a fixing) are indistinct.

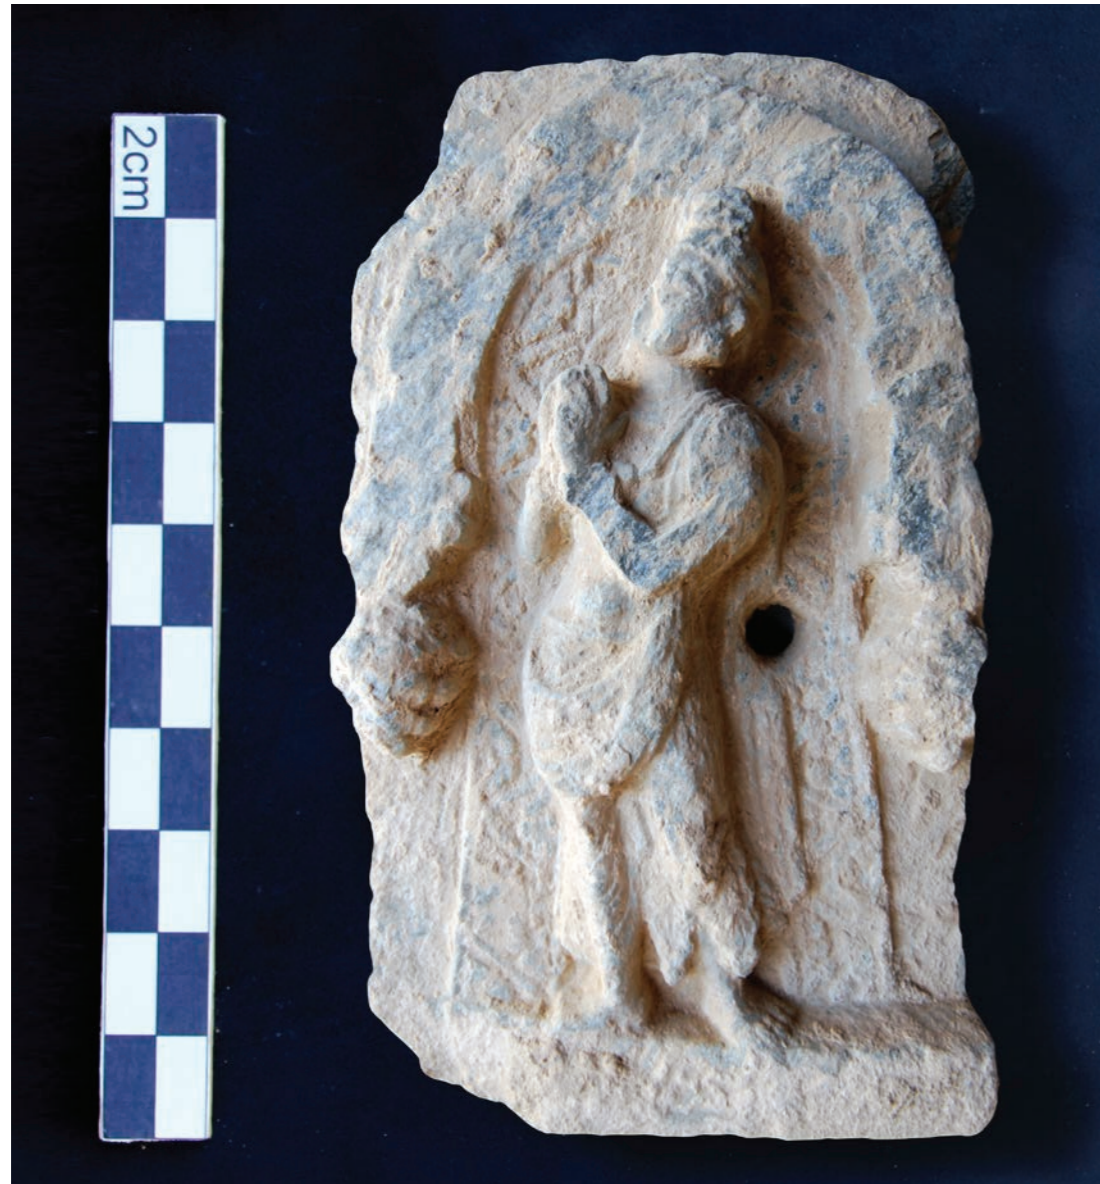
A third schist fragment depicts a standing figure in traditional dress, turning to the right-hand side and with hands clasped in veneration, set in a stylised arch. This panel, which has a hole for fixing, may have been one of those in the niches in the arcade around the drum. It bears a resemblance to stucco figures thought to represent donors to a religious complex, excavated at Tepe Narenj, near Kabul (Paiman 2013).

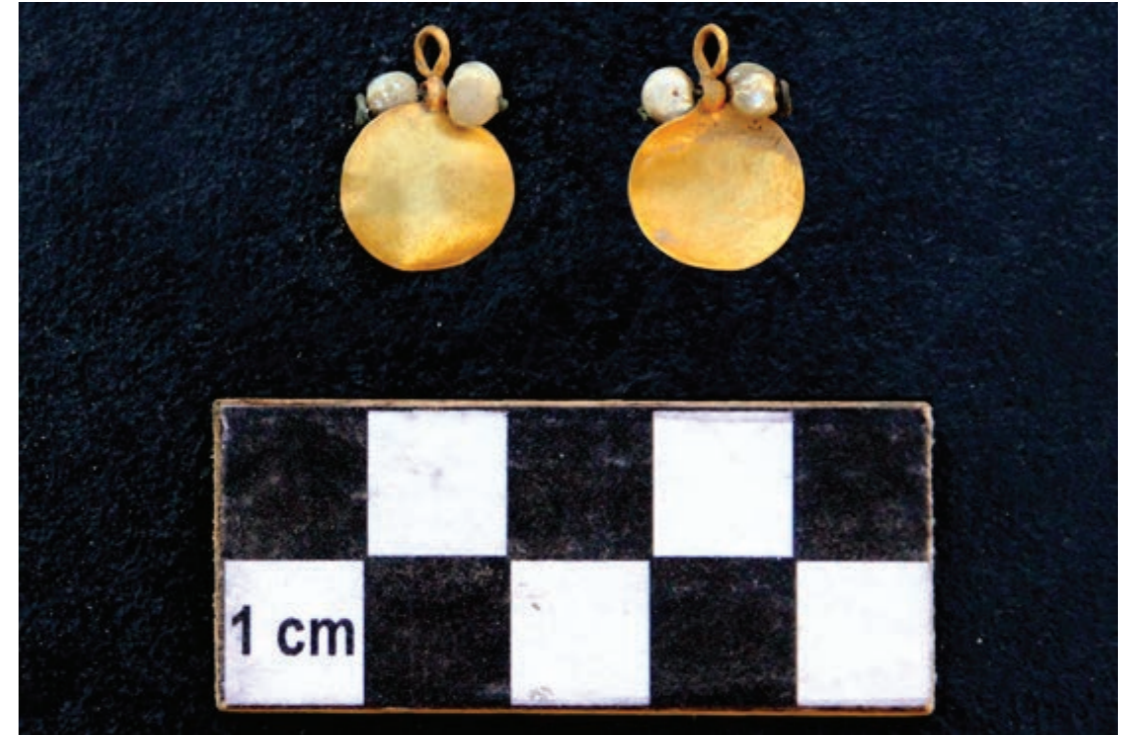
Among the other objects excavated at Topdara is a tiny gold and pearl ornament that may have been attached to a garment or used as jewellery.
